Report on Explorer Hut

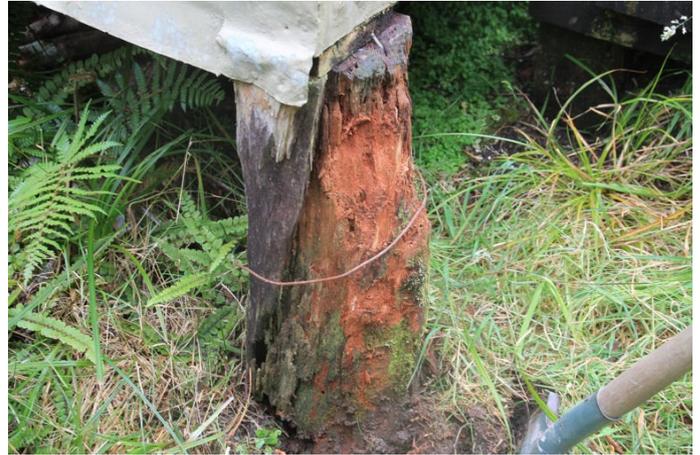
The South West corner pile was well rotted down the side from hut wall run off as it jutted out from under the wall cladding

South West corner pile

We dug out all the rotten piles and replaced them with outside treated round post sections, they were dug into the ground 400mm and set in concrete, the bearers were jacked up and then released after the concrete was set.

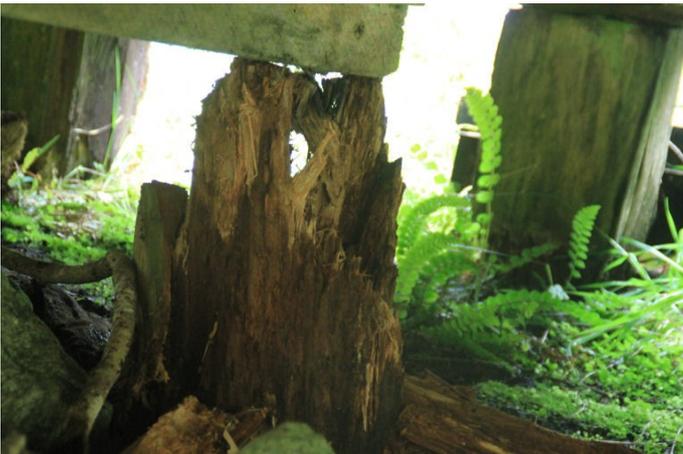
Centre right pile

The centre row of piles were all rotten to one extent or another, the right hand pile was almost non-existent. The middle pile was rotted off at ground level

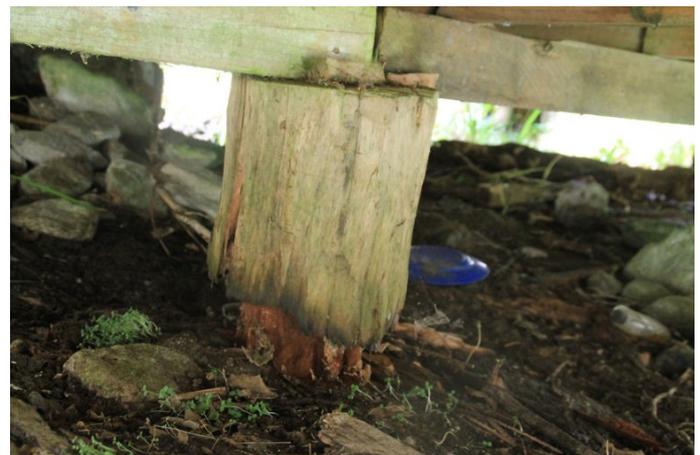
middle pile

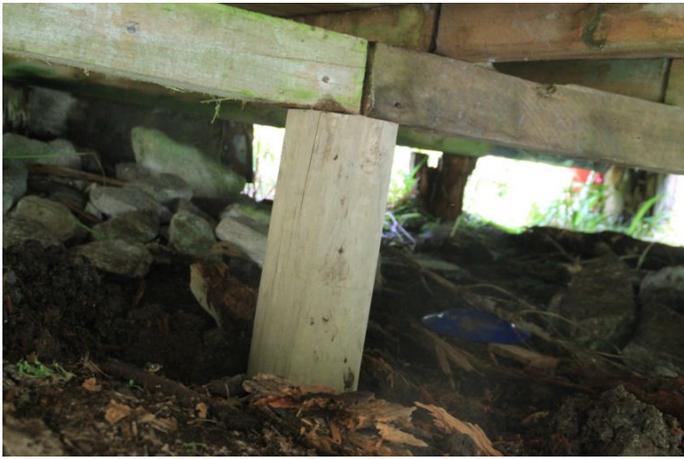
Centre pile in place

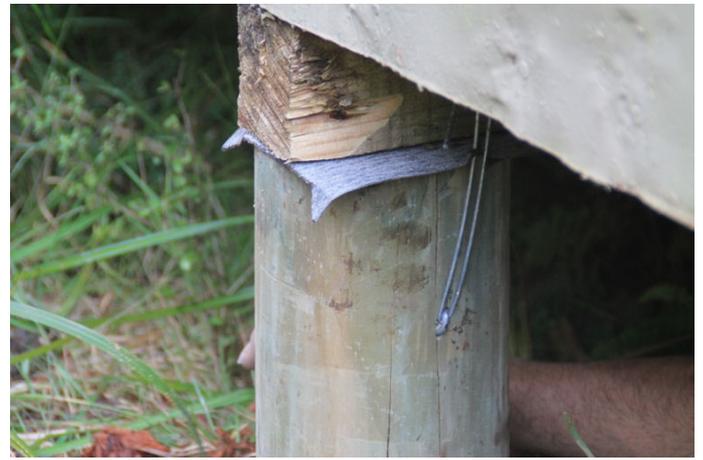
S W corner pile showing damp course and wire

The piles were topped with damp course and wired into place as well as skewed four inch nails, the piles that were too difficult to wire were fixed with “Z” nails.

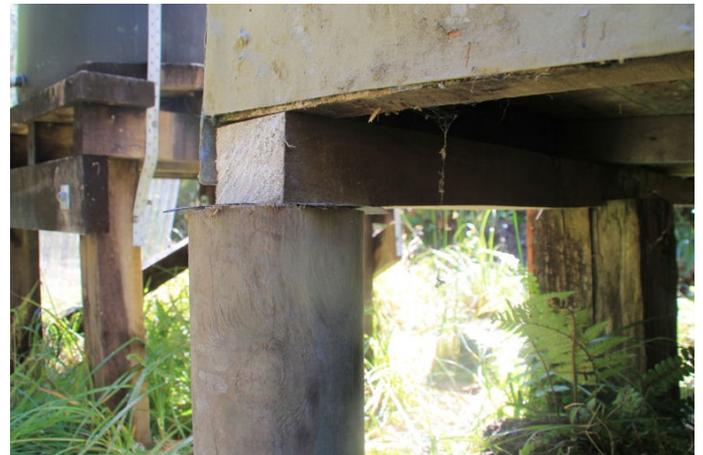
New S W pile and bearer

The hut has, in the past, been altered and an extra meter added to the South end but it was added with no bearers so we had to add bearers to the last pile span

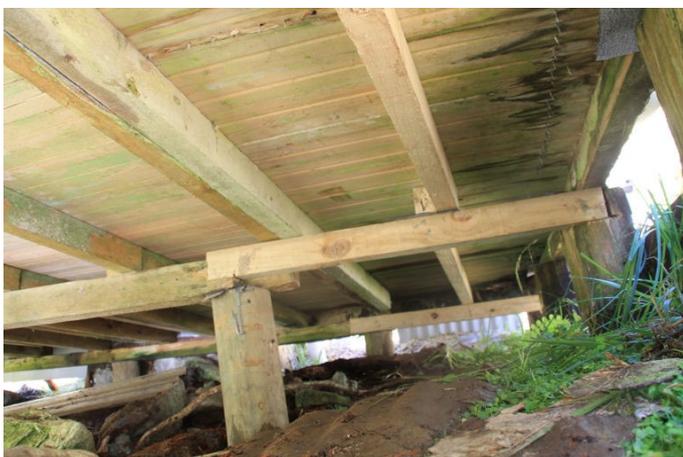
New bearers and joists on the South end

On the East wall the fireplace had been renewed at some date too, We found the remains of the old chimney rotting in the bush nearby, but only every second floor joist was replaced. We added a full joist under the new section on the South wall and added what joists needed on the East wall next to the fire place

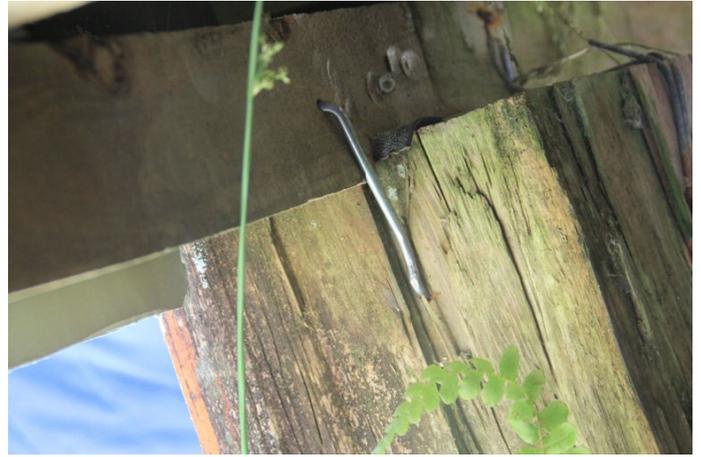
Old pile Z nailed and 4 inch skew nails

Once the damp course was placed between the piles and the bearers we “Z” nailed the piles and put 2 four inch nails skewed in. The piles that we could easily access we stapled wire over them

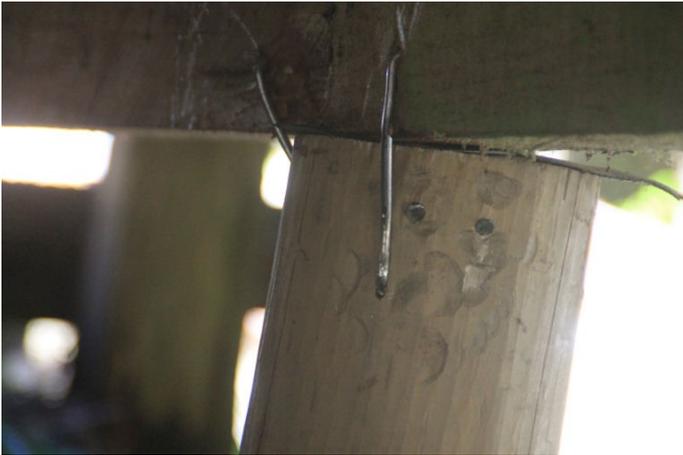
New pile fixed with 2 Z nails, 2 skewed 4 inch nails

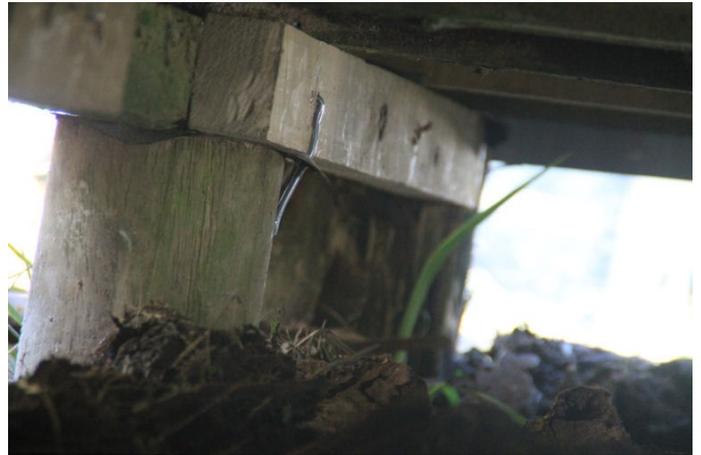
New bearer attached to pile

The new bearers were Z nailed and skew nailed into place also and on the North end of the new bearer we nailed them into the existing bearers.

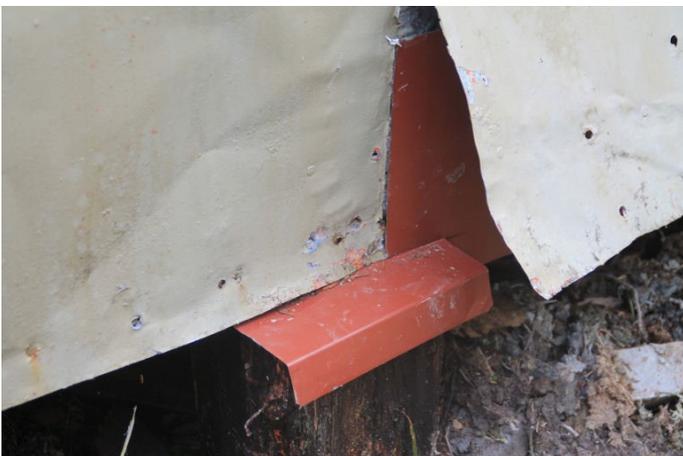
Pile flashing and side wall flashing

All the outside piles had new flashing added and where the side wall tin finished a little high we added a flashing to bring it below the top of the piles.

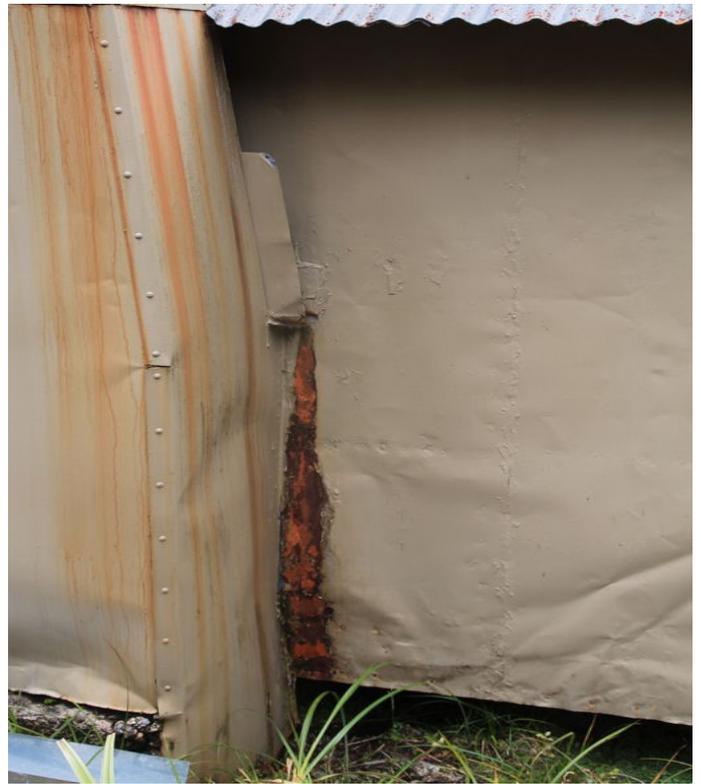
The chimney needed attention as the flashing between the hut and chimney was rusty and leaking, there was a hole in the side of the chimney and the top shroud was not wide enough and was letting rain in.

Rust coming out of the chimney to hut flashing

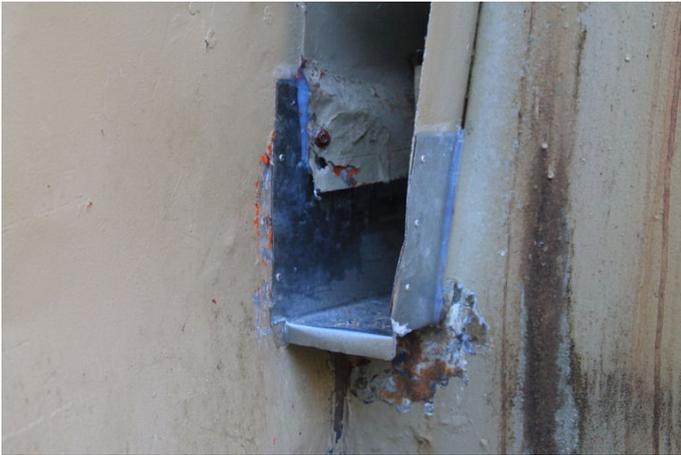
New flashing in place.

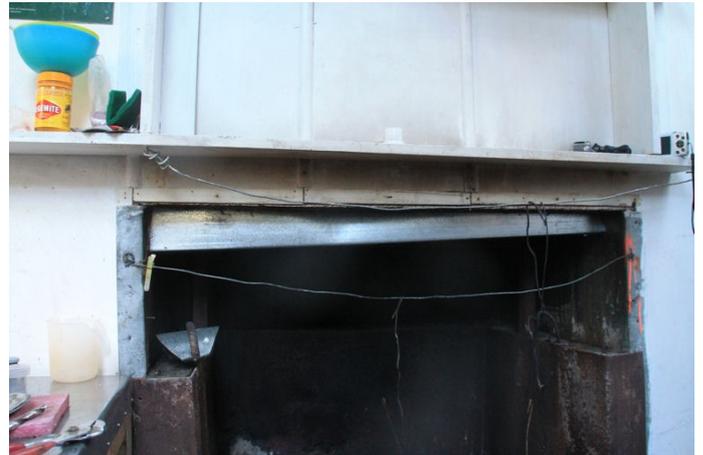
New flashing from the inside showing the slope for better water run off.

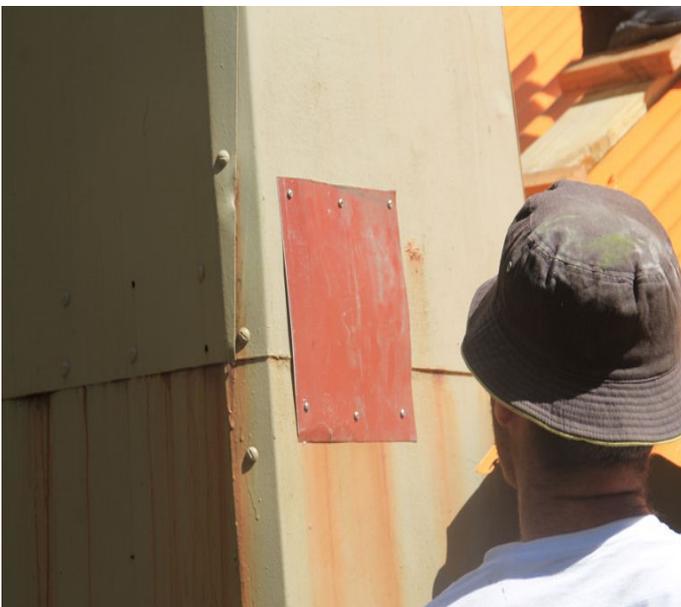
Patch on the side of the chimney

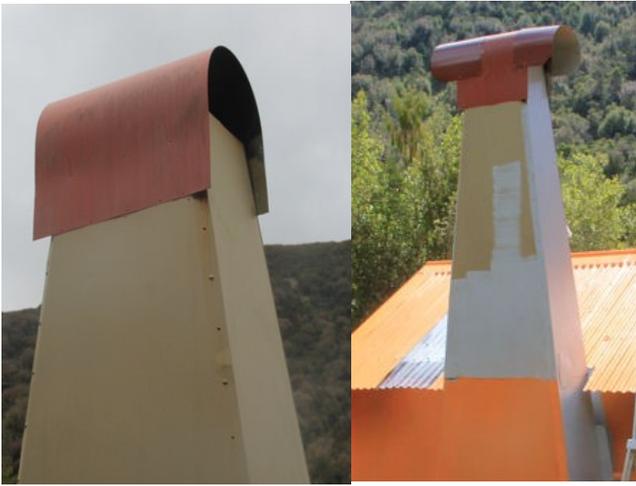
Hut roof shrouds before and after

Photo shows the old shroud size and the new extension we put on

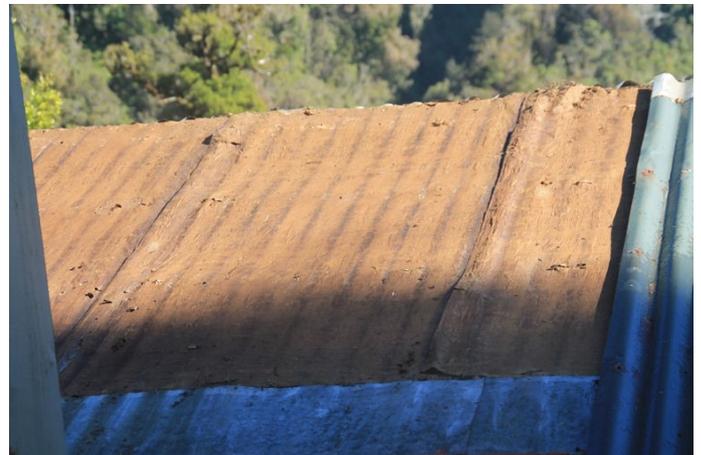
We took the old roof off and found that the tar paper was reasonably sound. We still covered this with new builders paper before replacing the roof with new tin and ridge cap. The edge of the old roofing iron was rolled over the edge of the hut but we put the new tin flush with the edge and placed new flashing on the edges

Old building paper

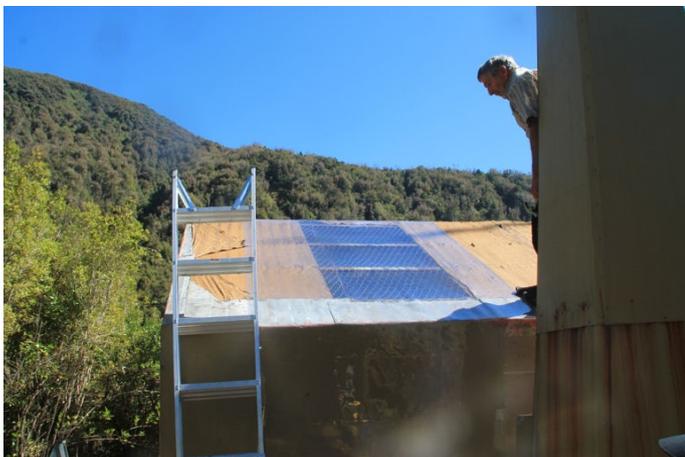
Clear PVC placed under the clear light

The PVC required to be well attached to the top of the ridge line and secured down each side because over time it will shrink from the sides if they are not secure

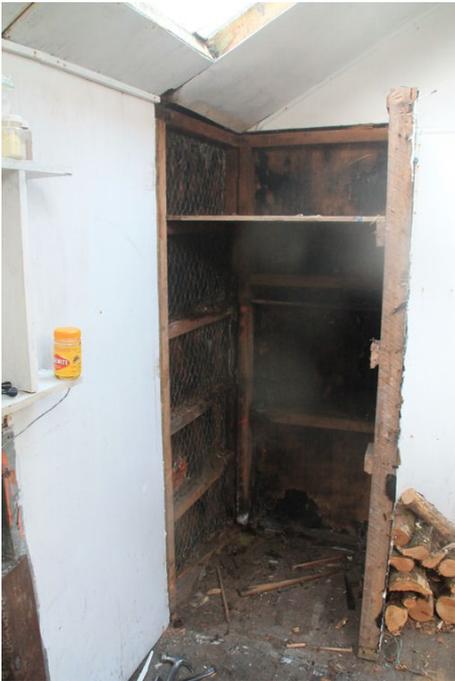
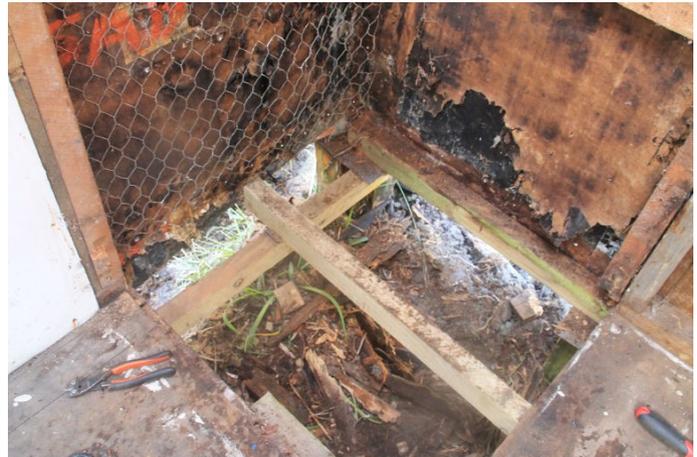
We then attacked the cupboard corner on the South East side of the hut, it was so bad we ripped the cupboard right out to get at the rotten floor, the rotten studs and rotten dwangs in that corner

Cupboard floor removed

We replaced the floor boards over the new joists we had put in earlier and then put in new bottom plates and studs, finally new dwangs were put in on the East wall.

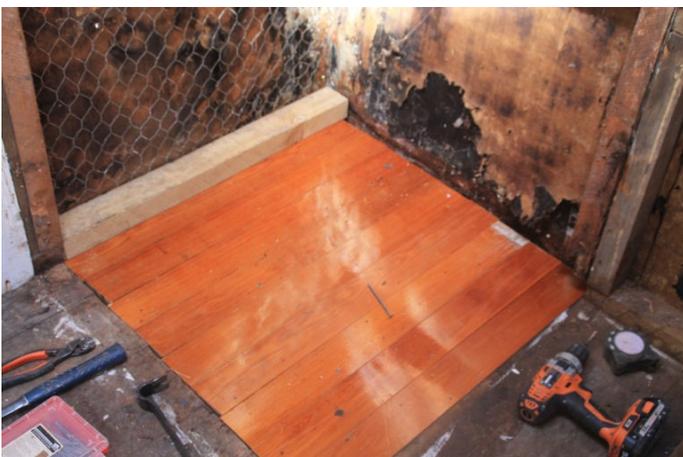
New floor in place

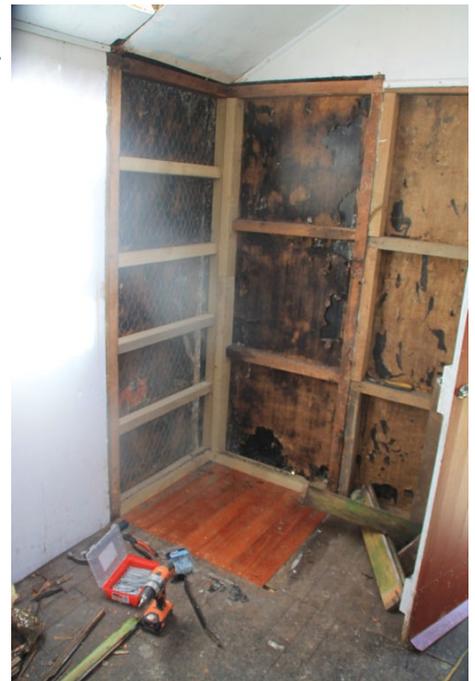
New studs, top plates and dwangs in place

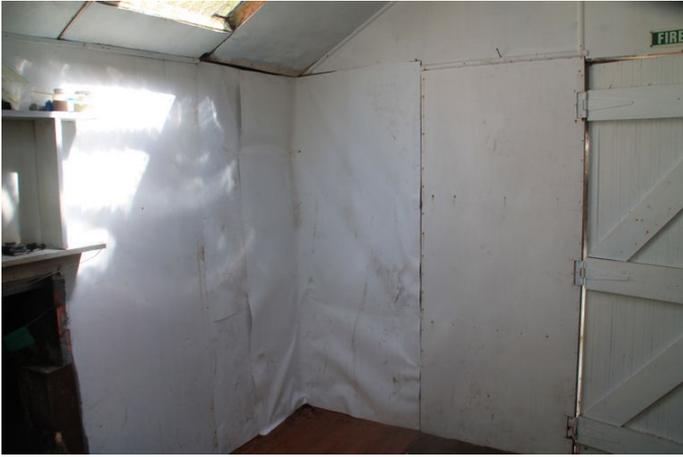
The cupboard corner tidy with building paper

The area was then tidied up with building paper as we had no extra wall lining to replace the bare cupboard walls.

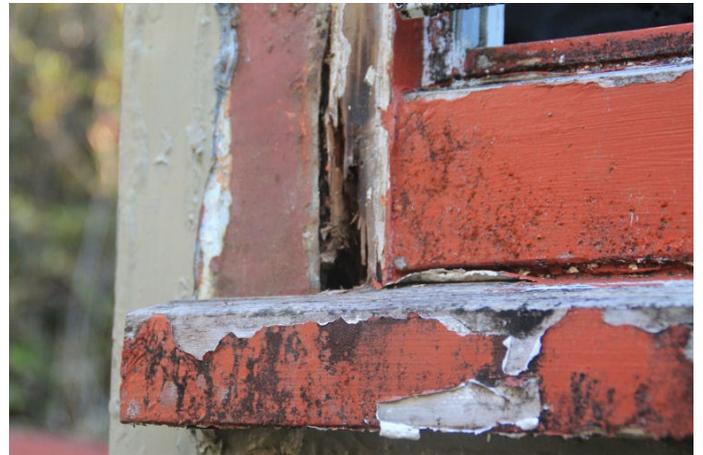
The rotted window was the next thing, just one small piece of rot was found in one corner of the window but on further investigation we found that the whole window needed to come out

Rot on outside of window

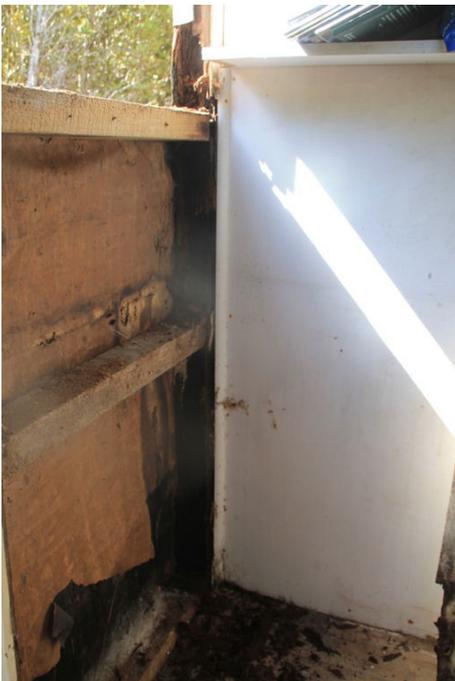
Rotted stud beside window

We spent some time extracting the window whole and doing a small repair on the window itself but we discovered that the whole stud beside the window was rotten as well as the dwang under the window.

The studs and dwangs for the hut corner and window were replaced and the window space lined on the bottom with tar sealer. The window was then replaced and a new piece of sash attached.

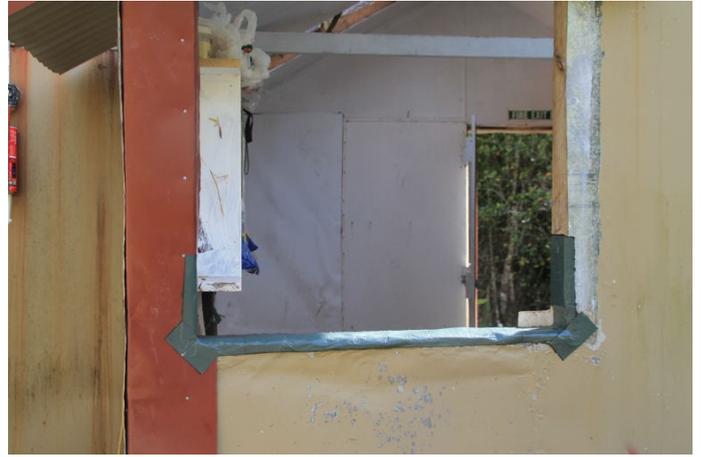
Window space sealed

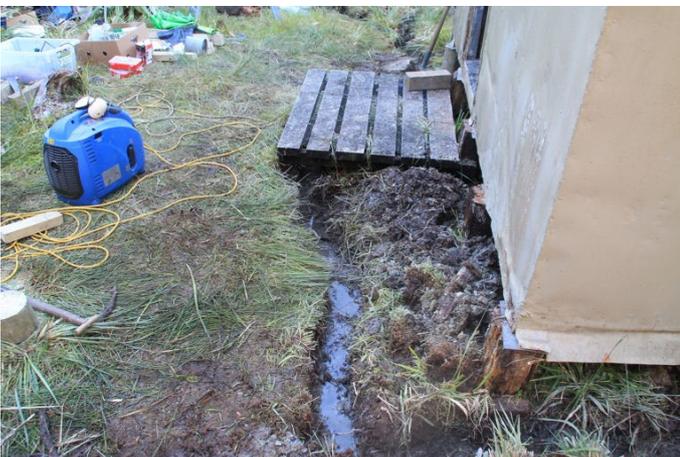
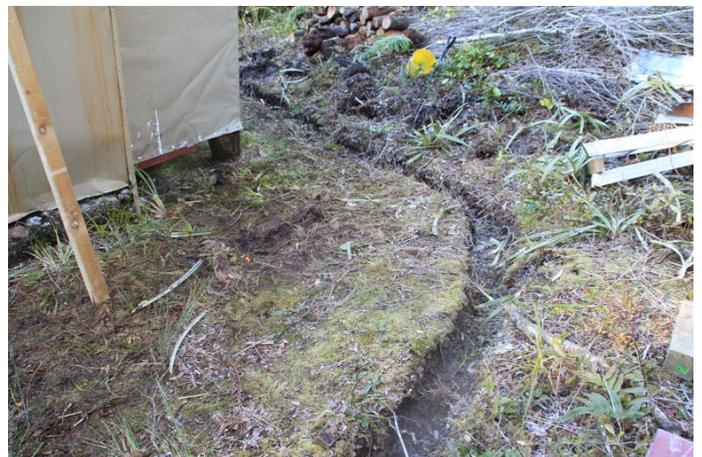
Ditches to draw water away from the hut

On the outside of the hut surround we dug ditches to try and divert some of the water from going under the hut. We dug a channel on both sides of the chimney to carry rain water off the roof away from the hut and another ditch around three sides of the hut to divert ground water from the surrounding slope above the hut from running under the hut.

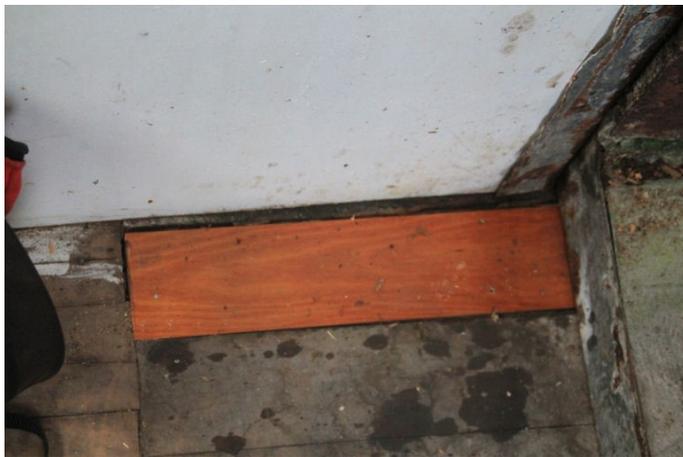
A small piece of rotted floor was replaced on each side of the fire place where water had run out of the fire place and onto the floor.

New floor in place on either side of fire hearth

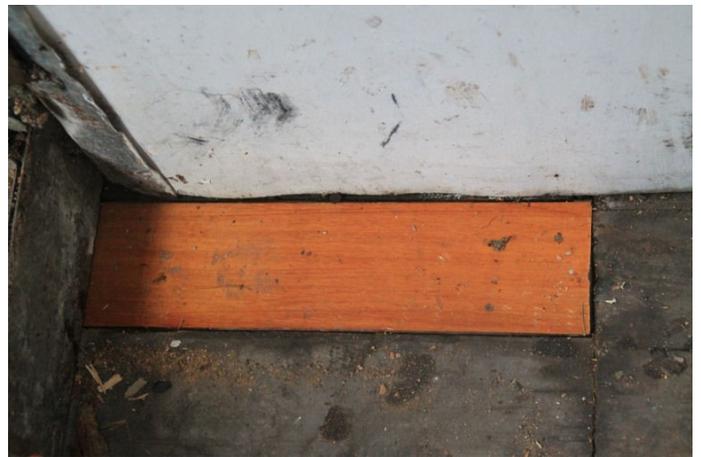
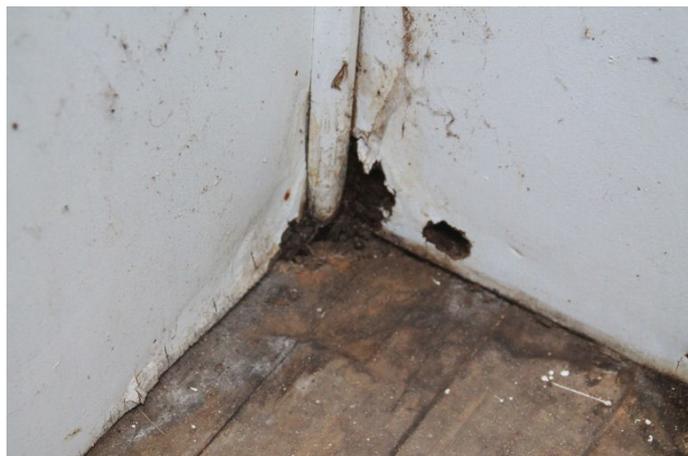
The second job not done is the rotten floor boards in the North West corner of the hut under the bunk, we suspect that upon opening up the wall it will be found that studs and dwangs as well as top plates will need to be replaced, some of the materials for this task are stored under the bunk. We suspect that another stud, 75x50 x 2mt, and several 50x50x500 dwangs and a couple of 75x50x500 top plates will also be needed.

Rot in the North West corner under the bunk, my finger went at least 100mm into the corner, we painted it fully with Metalex wood preserver in the mean time. This problem was not fixed
