WESTLAND EF HUT CARD

LOCATION NAME MUNGO
 CATCHMENT HOKITIKA
 NZMS SHEET NO 65 GRID REF 781180

HUT NO 227
 DATE BUILT 1962
 CATEGORY

HUT INSPECTION CHECK LIST

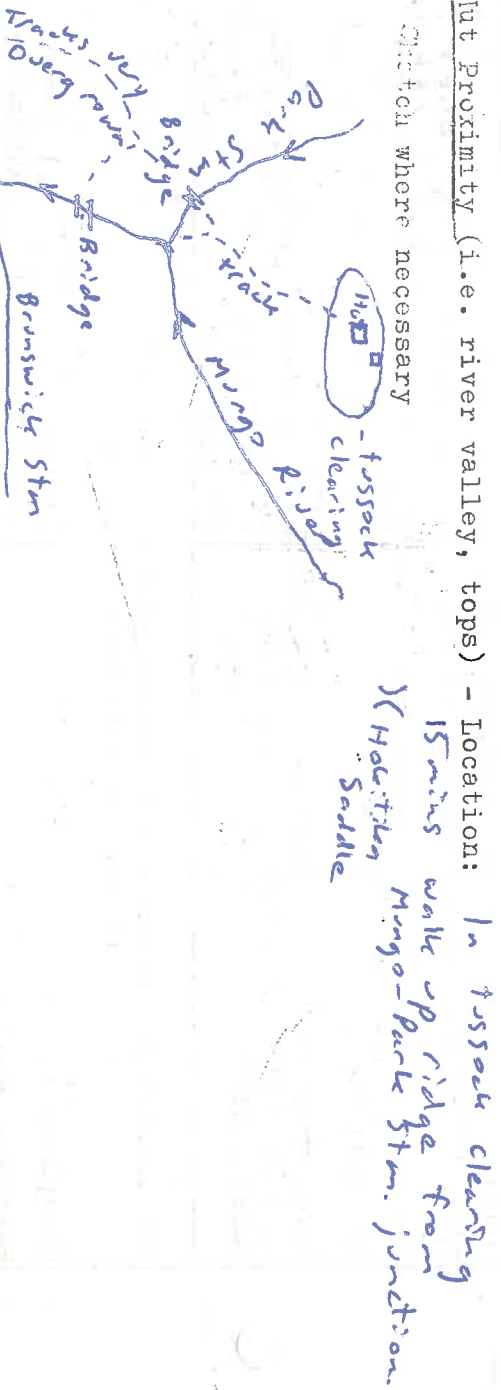
Sketch where necessary

Hut Site: Condition

- Swampy - tussock grass ~~brush~~ fairly high
