TUNNEL CREEK HUT PARINGA VALLEY SOUTH WESTLAND APRIL 2015

Geoff Spearpoint

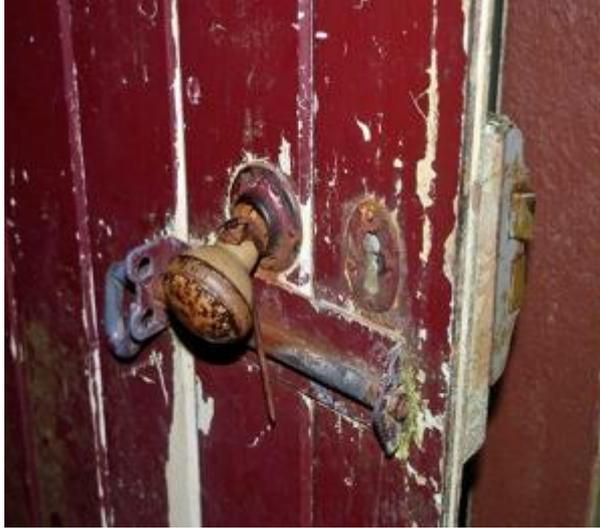
The doorhandle was so rusted as to be only half working.

Left, Hut door assembly and bolt, July 2012.

The door latch mechanism was replaced with a new one.

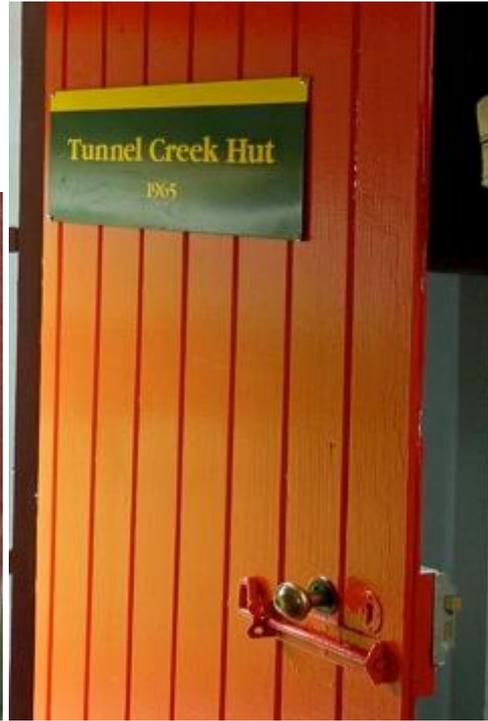
Right, new door

A weather protector was added to the bottom of the door to shed door water away from the hut and floor.

A wooden strip was added to the inside bottom of the door to seal it from vermin etc.

The door was stripped down and given an undercoat of Primer, then two top coats of Dulux Coatsville Red gloss.

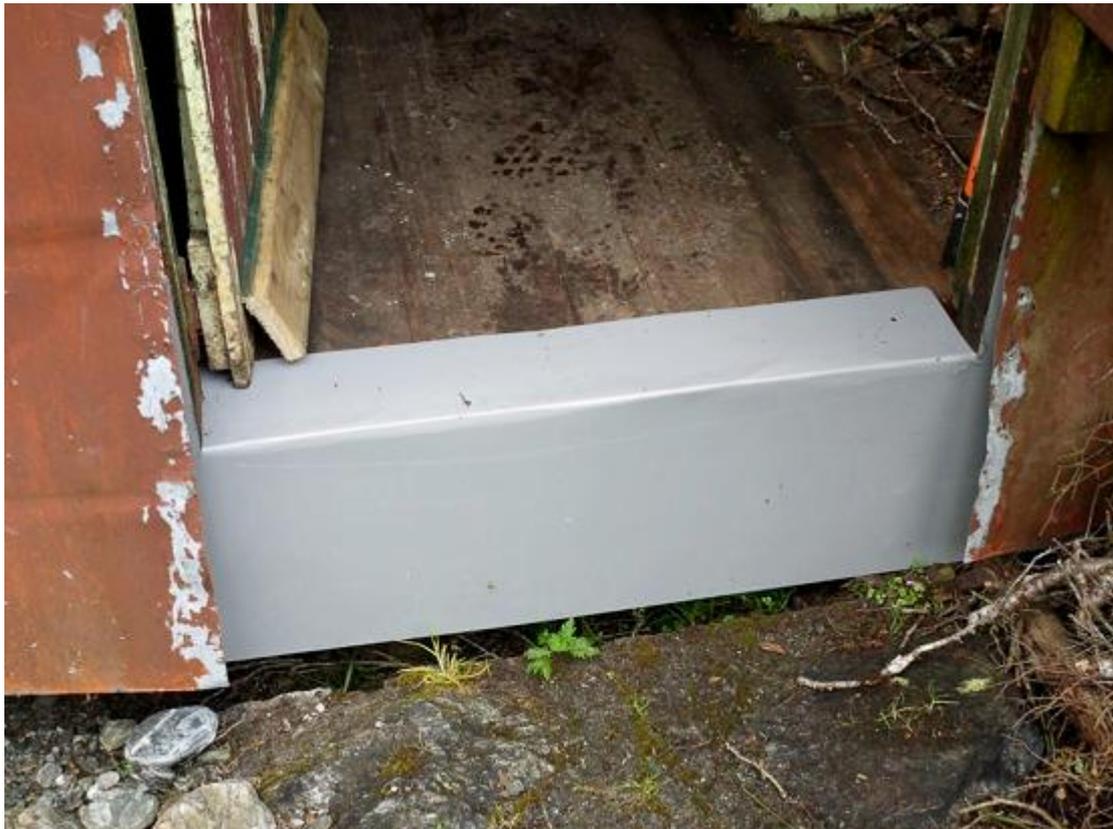
The metal doorstep protector was rusted and ripped.

Coloursteel doorstep installed, 2015.

The metal floor guard at the doorstep was replaced with new coloursteel flatiron.

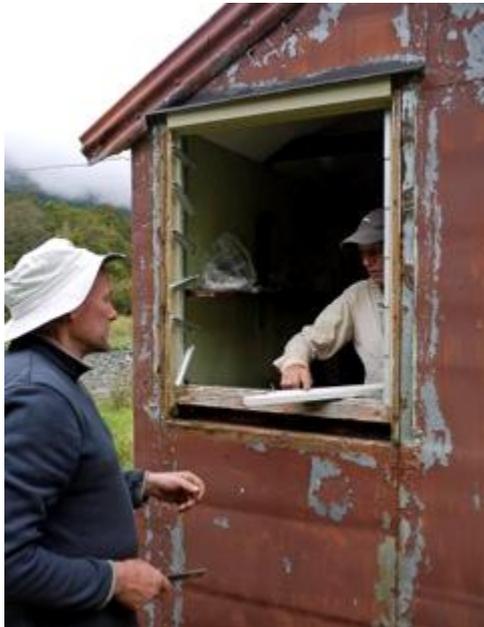
One window sill was completely rotten.

*Removing the rotten sill and replacing it, 2015.
window partly finished.*

I flew in a new windowsill sourced from a recycled building yard and Hugh and Peter replaced the rotten one under the back window. To do this, we took out the old window then reflashed the window.

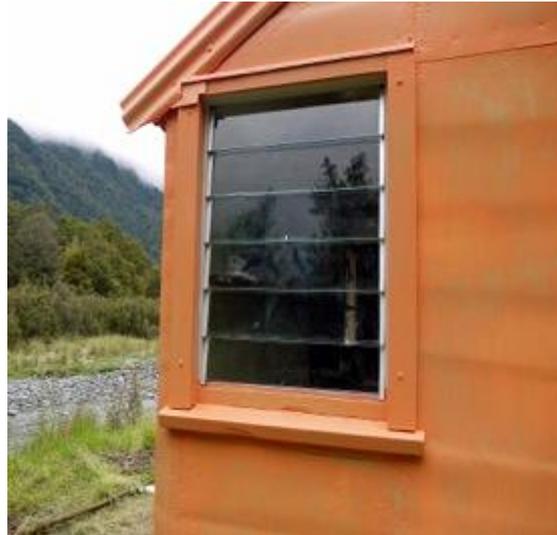
The sill replaced and

The window facings inside and out were cleaned, sanded, painted with primer, and then paint I had brought from home, British Paints H20 Enamel white higloss. Trim on the window by the fireplace was cleaned and painted similarly.

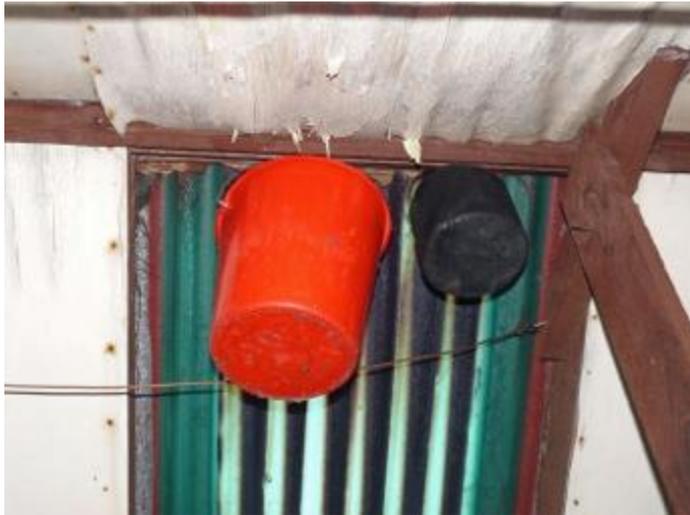
there were buckets hanging from the ceiling inside the hut to collect rain drips.

The skylight was narrow, badly affected by UV and had darkened with age to be of minor value any more.

Left, Bucket and billy set up by someone to catch drips along the skylight ridgeline, June 2012.

The skylight was replaced with new clear Suntuff polycarbonate corrugated sheeting. I have been aware of inside condensation issues with these skylights

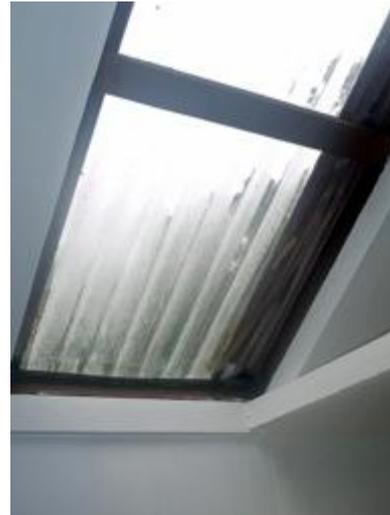
Right, Skylight replaced and PVC liner in place underneath, 2015. Condensation is only on the outer corrugate. Ill monitor the liner and see how it performs.

for years. Plastic sheeting underneath designed to catch condensation quickly breaks down and sags. So I have trialled clear PVC/PVU sheeting, often used for windows in caravan awnings etc. This is of midweight, and I am hopeful it will work. The screws were removed from the Suntuff corrugate (bar one at the top) and the PVC was then run underneath the corrugate to continue to the outside at the wall. A batten holds the PVC evenly near the ridgeline, and the screws replaced. A batten keeps it secure outside under the eave. I had thought I would need side battens to keep it stretched out, but that has proven unnecessary at this stage.

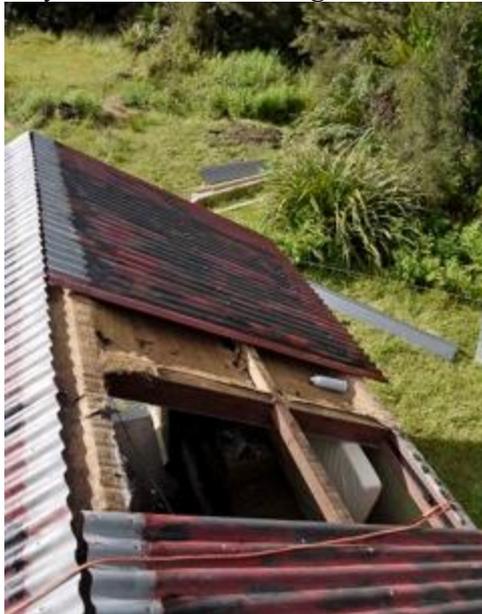
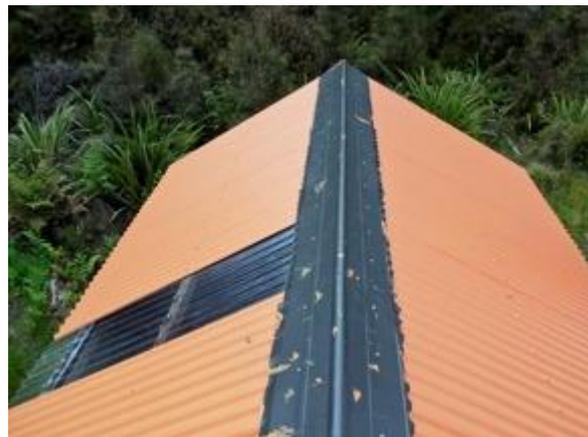
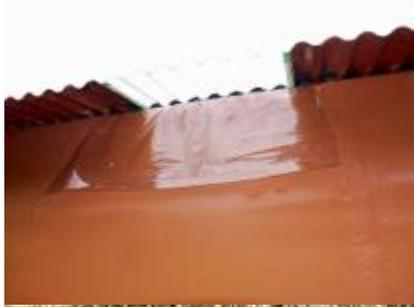
The roofing iron had many rust spots on it, the ridging was badly rusted.

Above left, Skylight off, 2015. Above right, Ridging and skylight replaced, 2015. Below, skylight and PVC sheet.

I bought new wide ridging to replace the rusted and poorly fitted existing sections, screwing it down with tech screws and sealant. The ends were cut and folded down and screwed, with sealant.

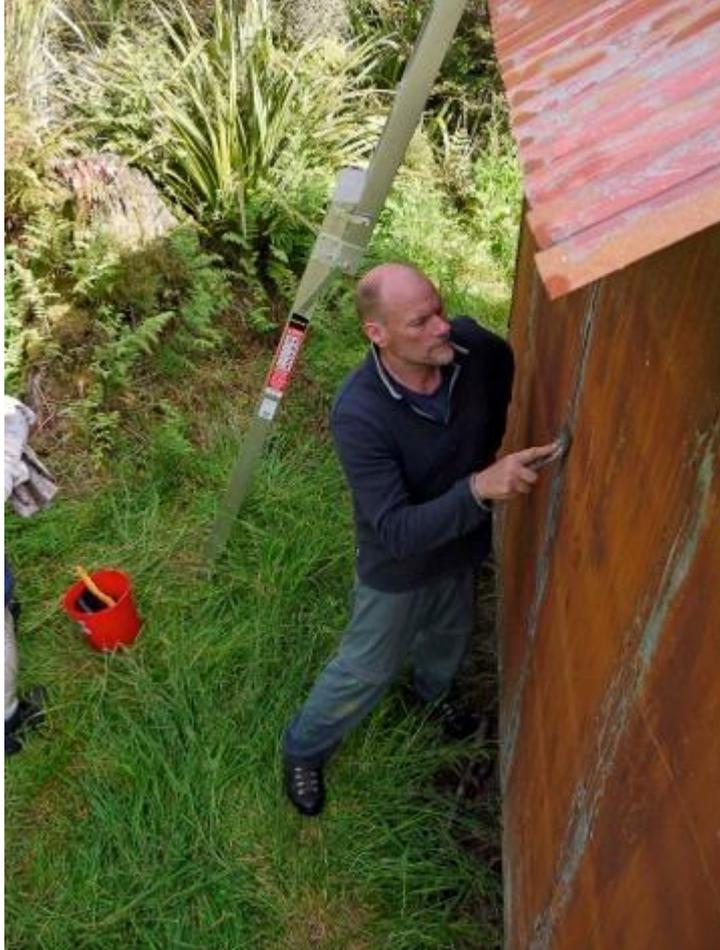
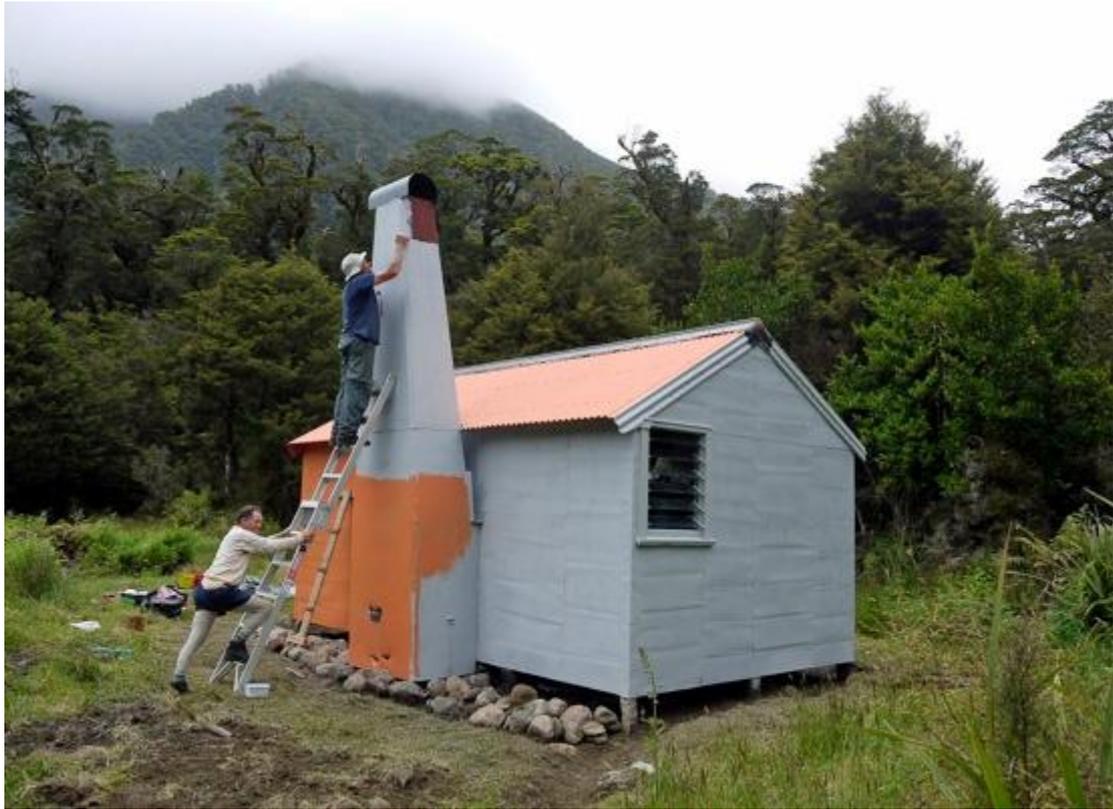
The last painting of the hut with brown seems to have been poorly done or was done in poor weather. Much of it was peeling or had gone, though in many places the original orange coat was still useful protection. The exception to that was the roof, where many rust patches were coming through the paint, indicating wider failure.

Above, Hugh scraping down the walls. Below, Hugh and Peter painting the chimney.

We wire brushed all the roof, especially the rusted spots. We treated the rust spots with CRC Rust Convertor (similar to Black Guard). This halts the rust and forms a Primer seal that can then be painted.

Painted the whole roof with Dulux Quit Rust Primer (and all the outside walls as well, after the same treatment). The exterior of the hut was then painted in Dulux CONZ40 'Mangatainoka' gloss. This looked a bit pale and bland on the whole hut, so on the next trip I bought 4 litres of Dulux Weathershield 'Coatesville' red Higloss to do the roof and door, 2 coats each. Looks much better. The exterior walls have all had primer, and 2 or 3 coats of Mangatainoka to finish.

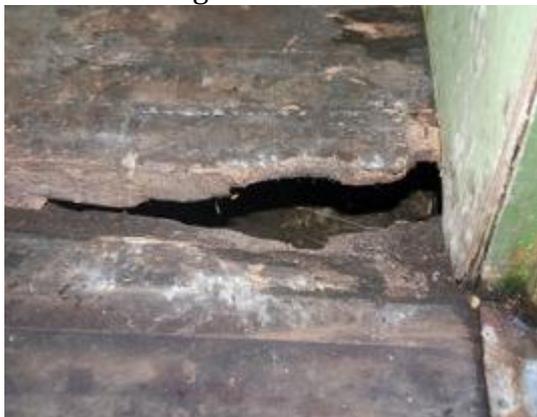
There were damp, rotten and broken floorboards beside the fireplace, at the door, and a couple of other places. There were holes in the floor.

Left, Rat hole beside door, 2012.
Left, Rat hole beside door, 2014.

I replaced 5 floorboards near the door, after a brace sitting on the bearers was added between the joists to give more support in this hard used area (photo). Because of dampness and the fact that some boards had rotted here, I used Metalex to better preserve the bearers, joists and plates here too. I also used Metalex in a couple of other places on the hut- other broken flooring, under the door, and framing around the replaced window sill.

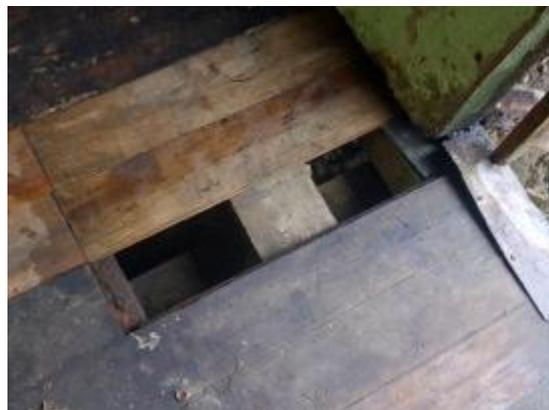
Right, Replaced boards beside door.

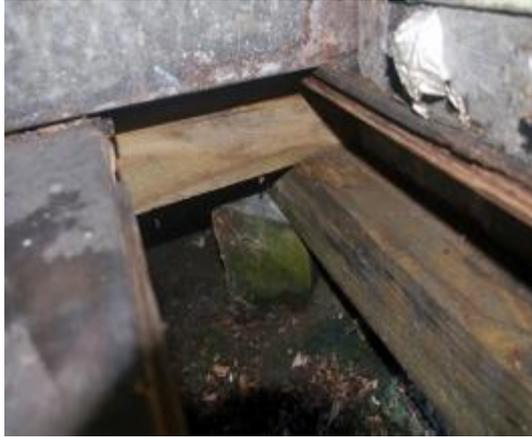
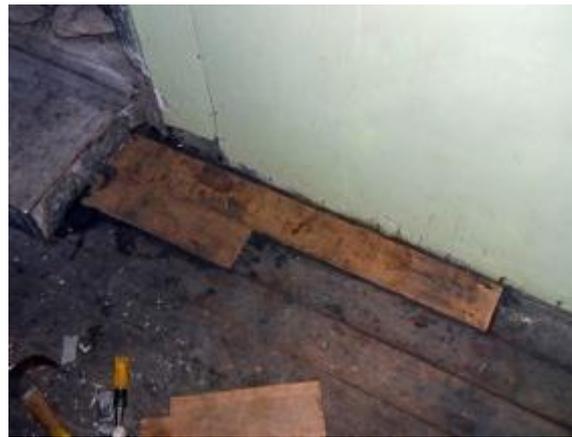
Left, subfloor detail after rotten boards were removed beside the fireplace and Right, floorboards replaced, 2014.

Replaced a broken floorboard in the middle of the hut, and others at the corner of the fireplace where a couple had rotted.

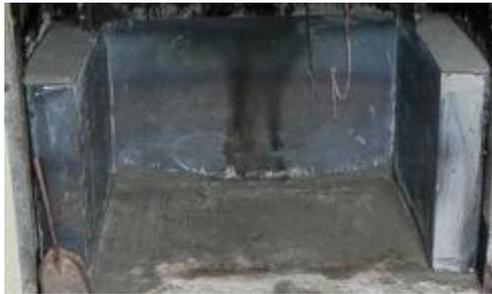
The steel liner in the fireplace was rusted out.

The freestanding steel plate fire liner in the hearth protecting the chimney was replaced with a new one of 3mm mild steel, and concreted in.

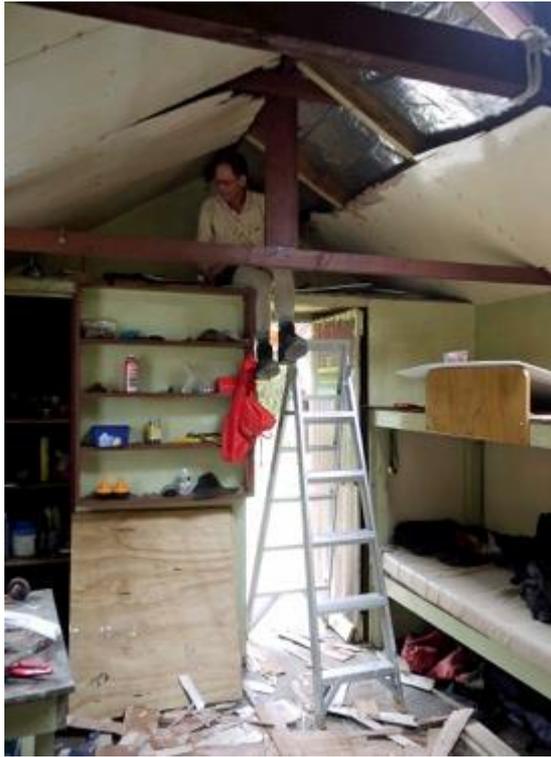
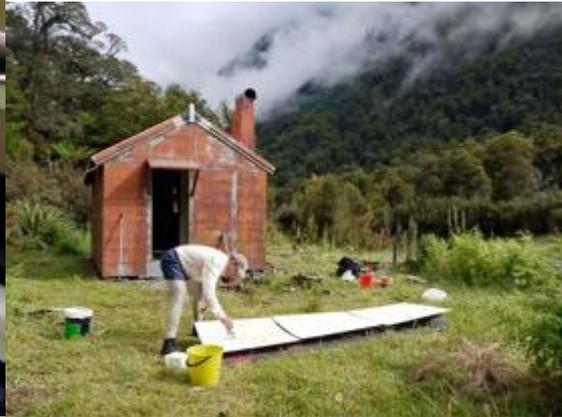
Many ply panels inside were delaminating and peeling from the ceiling.

Above, Peter removing ply, Dec 2014. Right, Peter undercoating ply panels.

All the warped and delaminating sheets of ply on the walls and ceiling were replaced. The bunks were pulled out from the walls and put in the middle of the room then all the interior walls and ceiling were scrubbed down with what detergents we had and cleaned off before painting. They were given mostly three coats of white semigloss paint.

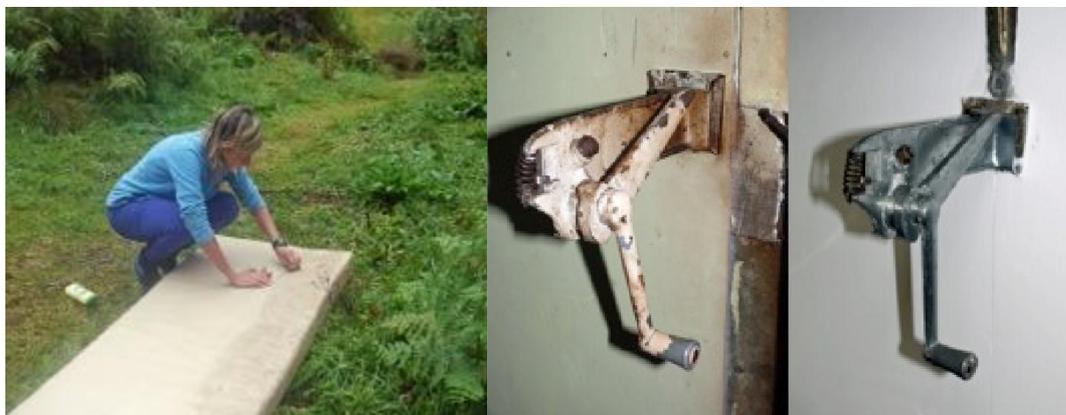
The mattresses provided some consternation. They were covered in greasy mould and initially proved very hard to clean using Jif. Liz struggled for a couple of days on them. Since then we have discovered that the secret is bleach. Bleach kills the fungi and lifts the mould off. The mattresses are all clean and tidy at the moment. Antimould in the paint should help cut down spore numbers.

Left, Liz scrubbing the mattresses, April 2014, Right, The original can opener by the fireplace, restored.

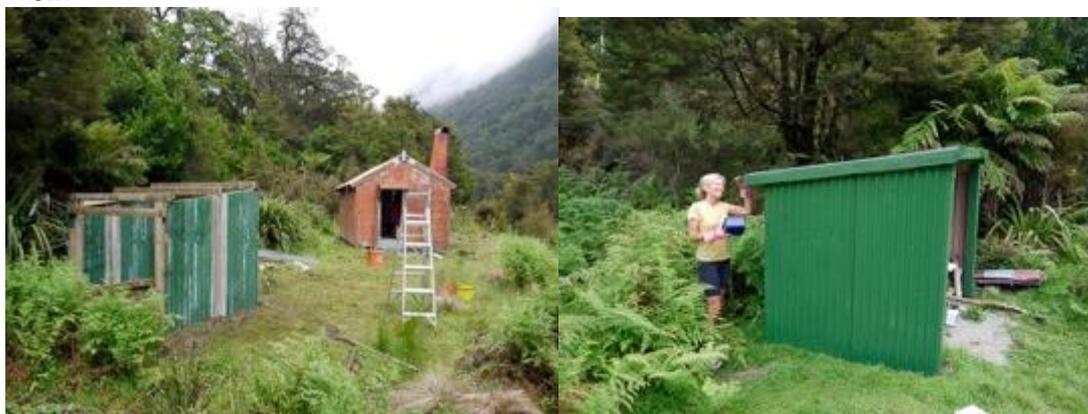
A makeshift piece of iron lean-to on the south side of the hut was meant to hold spare firewood, but being on the south side attracted dampness and sandflies to the door.

Building and painting the woodshed, 2015.

The only wood storage area was the porch and a damp lean-to less than a metre off the ground nailed up with local beech poles to the wall beside the door. I was keen to offer a practical alternative to a porch full of damp musty wood. I brought in H4 treated pine posts and 100x50 railings for the frame and coloursteel for the roof from Christchurch. The walls are older iron salvaged from my roof. The dimensions are approx. 2.2m across the front, 1.7m high and 1.5m deep. I sited it for maximum sun, and concreted in the posts. The rafters were then metal strapped to these posts for strength in wind. The corrugated iron walls were cleaned and initially painted with 2 coats of Dulux 'Iron Pot' inside and out, but the colour didn't go well with the hut. Since then, I have taken in a couple of litres of roof paint from home, Taubmans 'Greenstone' gloss, and repainted the outside. Looks much better. The woodshed appears to be working well.

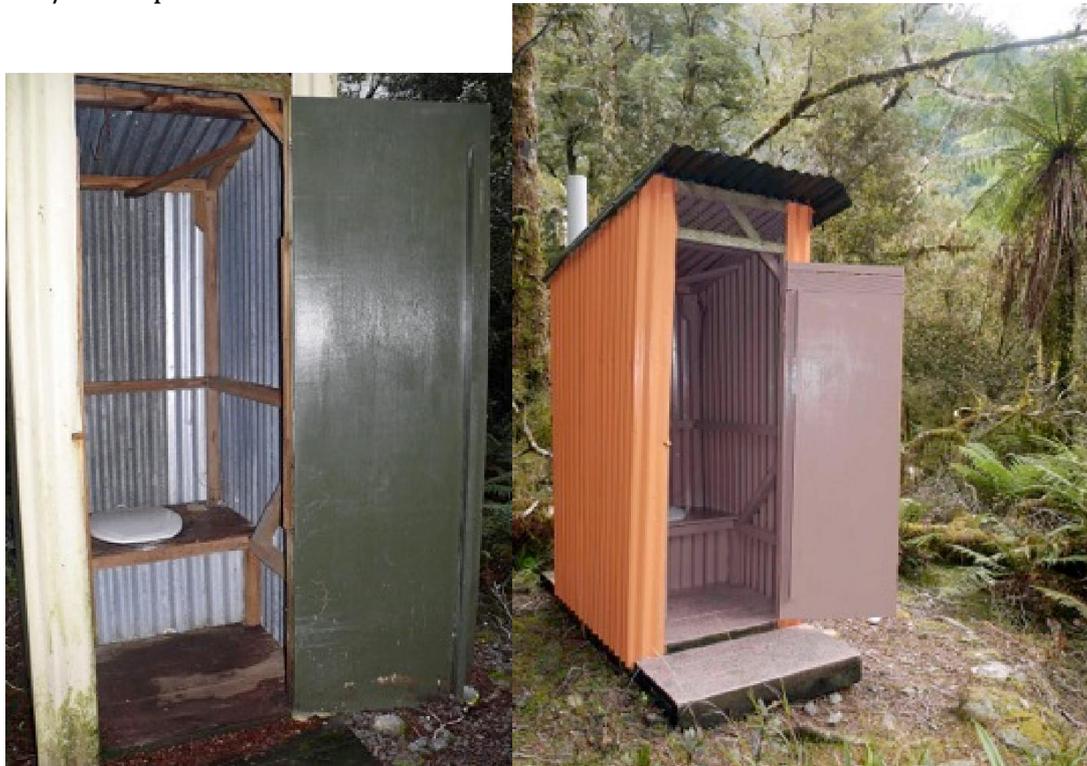
The toilet door was rotten in one corner, and the 2 hinges completely underspec, and more appropriate for a kitchen cupboard.

The bolt had rusted off, and the door was being kept shut with a rock.

Left, The toilet, July 2012, and Right, the toilet with door rebuilt scrubbed and painted 2015, Below, directions.

The toilet door was taken off and rebuilt, cutting out most of the rot. However, it may need replacing in a few years, and I will keep my eye on this. I replaced the hinges with more appropriate ones, and also added a new bolt on the door. The outside was painted with 2 coats of 'Mangatainoka' orange exterior gloss Dulux paint, and the inside with Dulux 'Iron Pot' mushroom colour. This has improved the hygiene and look considerably. The wooden doorstep to the toilet was very greasy, and I mixed sand/gravel fines into the paint and sprinkled more on top to produce a non-slip surface. I also properly marked the track to the toilet with red/white permolat.
