# Upper Spey Hut - Dusky Track

## Reroof & Maintenance Report– May/June 2020

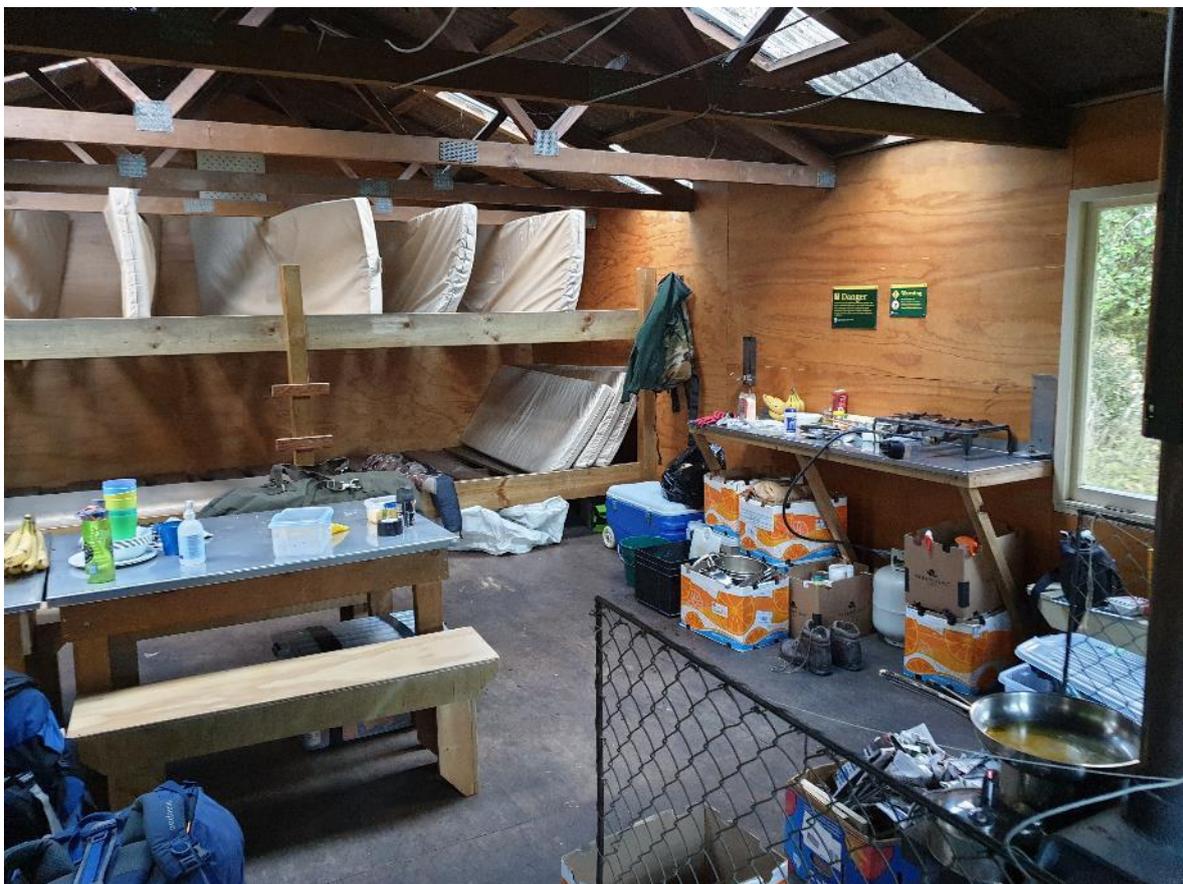
**Pre reroofing internal of the Hut**

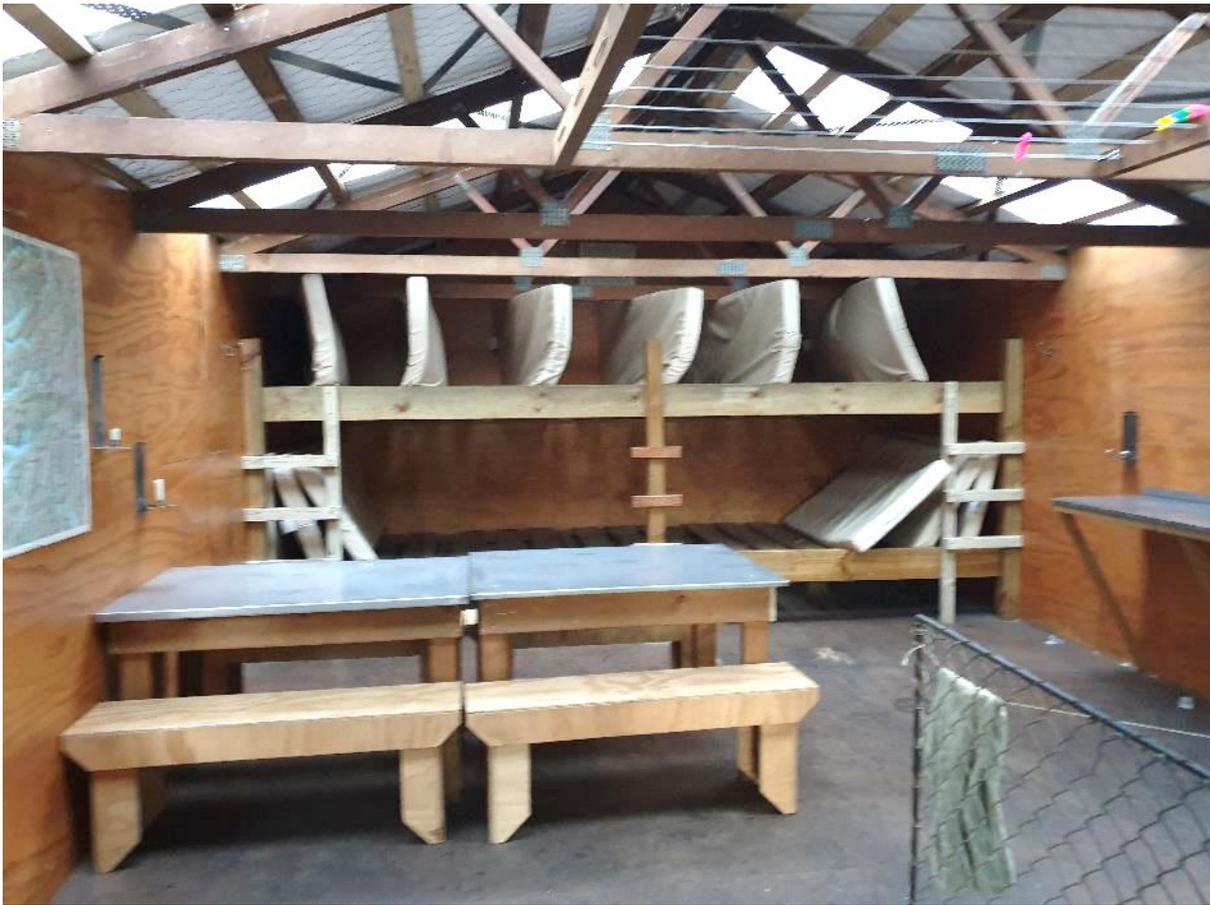
**Post reroofing internal of hut and new bunk access**

So the bunks were jacked up and a foundation support spreader was installed to distribute the weight over the ply floor and nearby structural support elements. There was also no safe ladder for the top bunks, so we built a ladder at each end of the platform in the same style as the central ladder for in keeping of construction methods as well as added extra foot holds for the central ladder to make it safer.

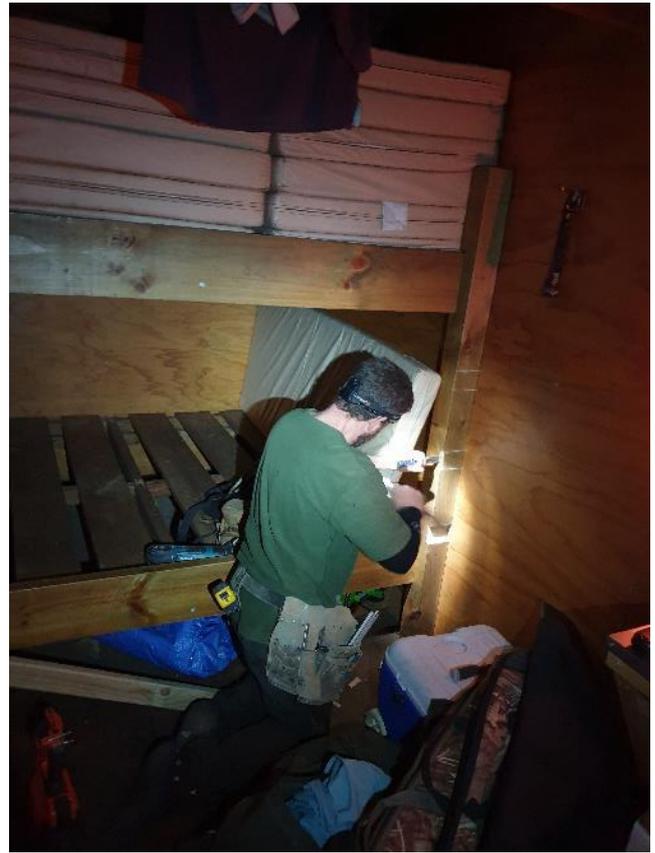
**New step construction for bunks**

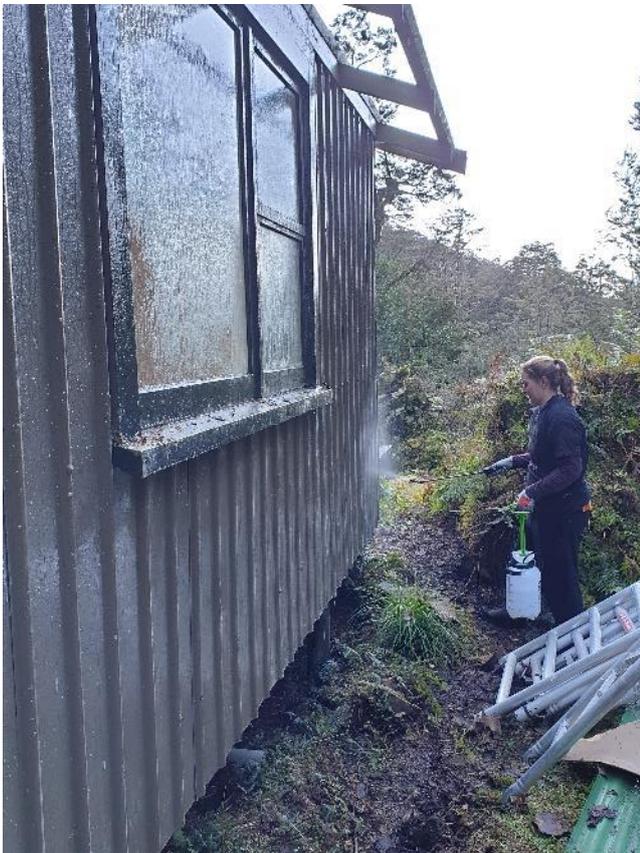
**Exterior cleaning**

While the roofing work went on, with new structure, bracing, netting, membrane and iron and clearlight a team started on the cleaning of the hut and walls with scrubbing brushes and brooms. With one member of the cleaning team also acting as the roustabout being dragged from one side to the other passing timber, screws, tools etc as the roofing team screamed their demands as they went about their jovial work.

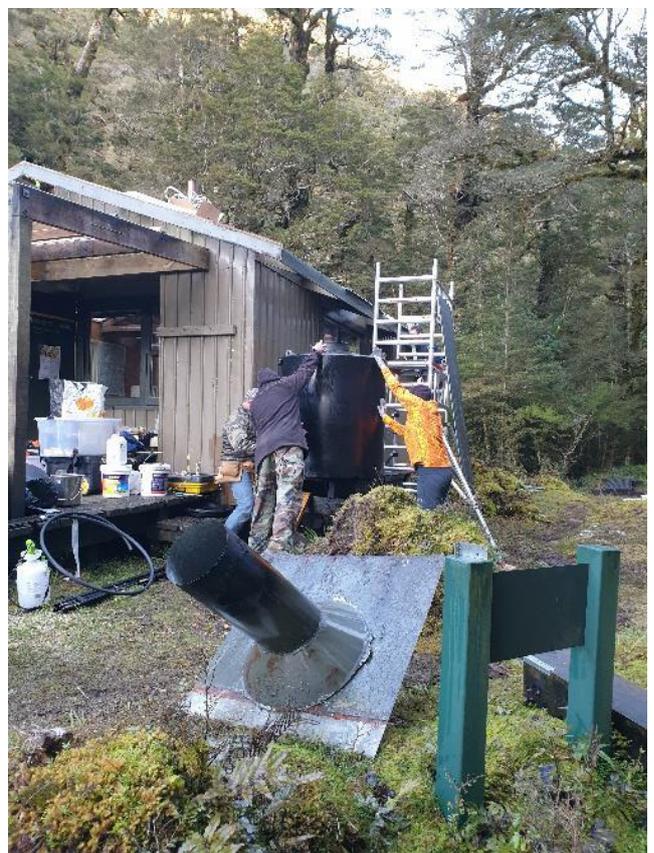
**Tank removal**

The water tank was drained and deconstructed so we could clean it inside and out, put back in position with new, new stainless seismic restraints. The tank platform was also cleaned and scrubbed back to timber to remove the moss and lichen growth.

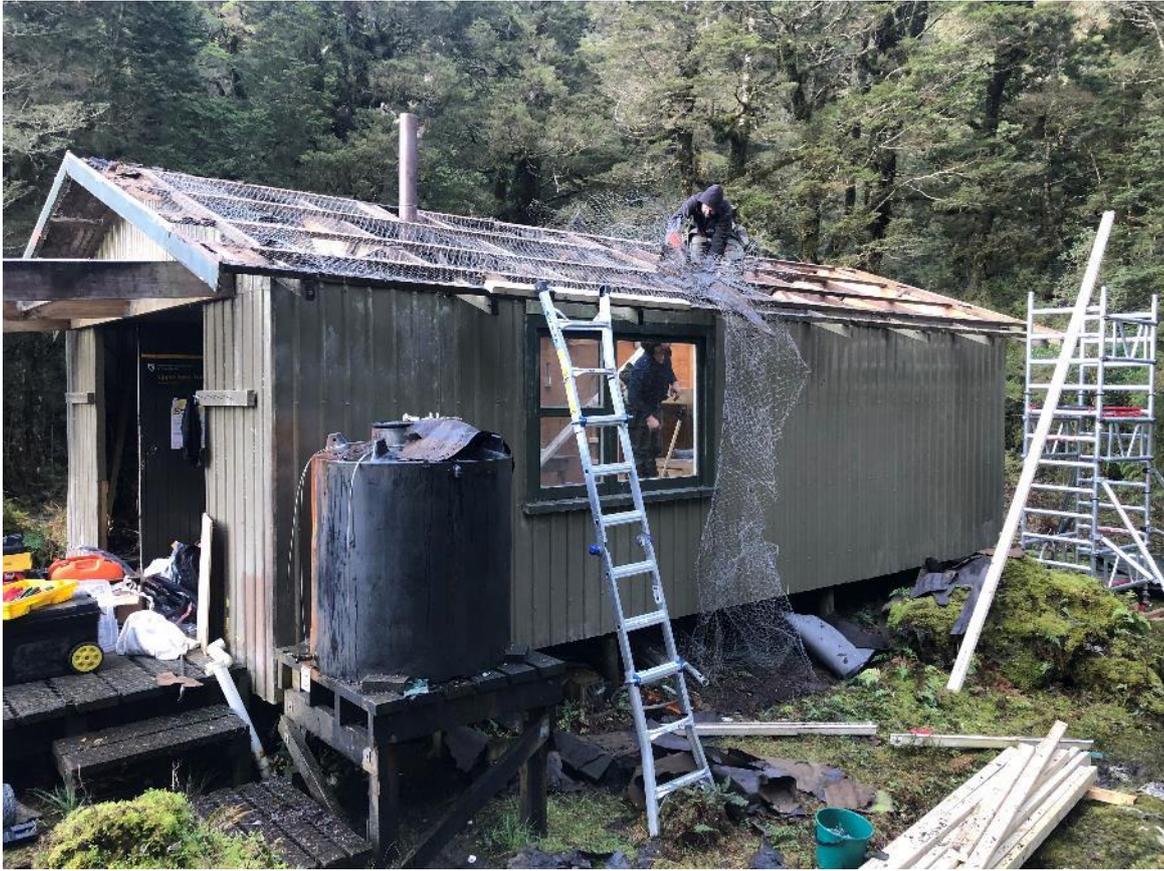
**Roof deconstruction**

It took a while to remove the roofing iron, the old chicken wire and what was left of the building paper off the roof and equally as long for those not on the roof to tidy up the rubbish and condense it in a fit enough and safe way in the net to fly it out under the helicopter.

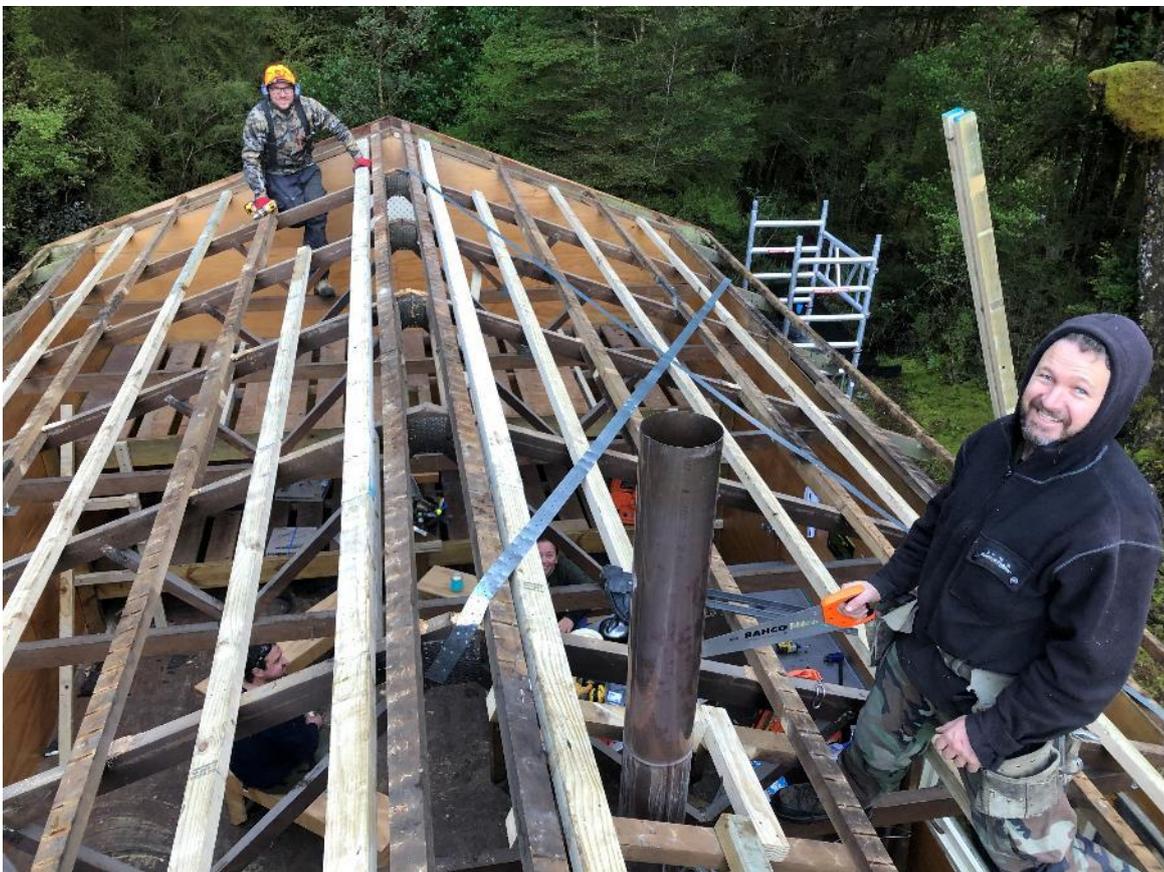
**Restructure and bracing of roof underway**

Once the roof was deconstructed, we started on the reconstruction and essentially doubling the purlin elements of the roof. It was amazing at how flimsy the hut became without the roof and even the smallest shake of the rafters would send the hut into a strong sway reminiscent of a mild earthquake that even shook the pile foundations. This became a running joke that by shaking the bunk platform you get the hut “rocking.”

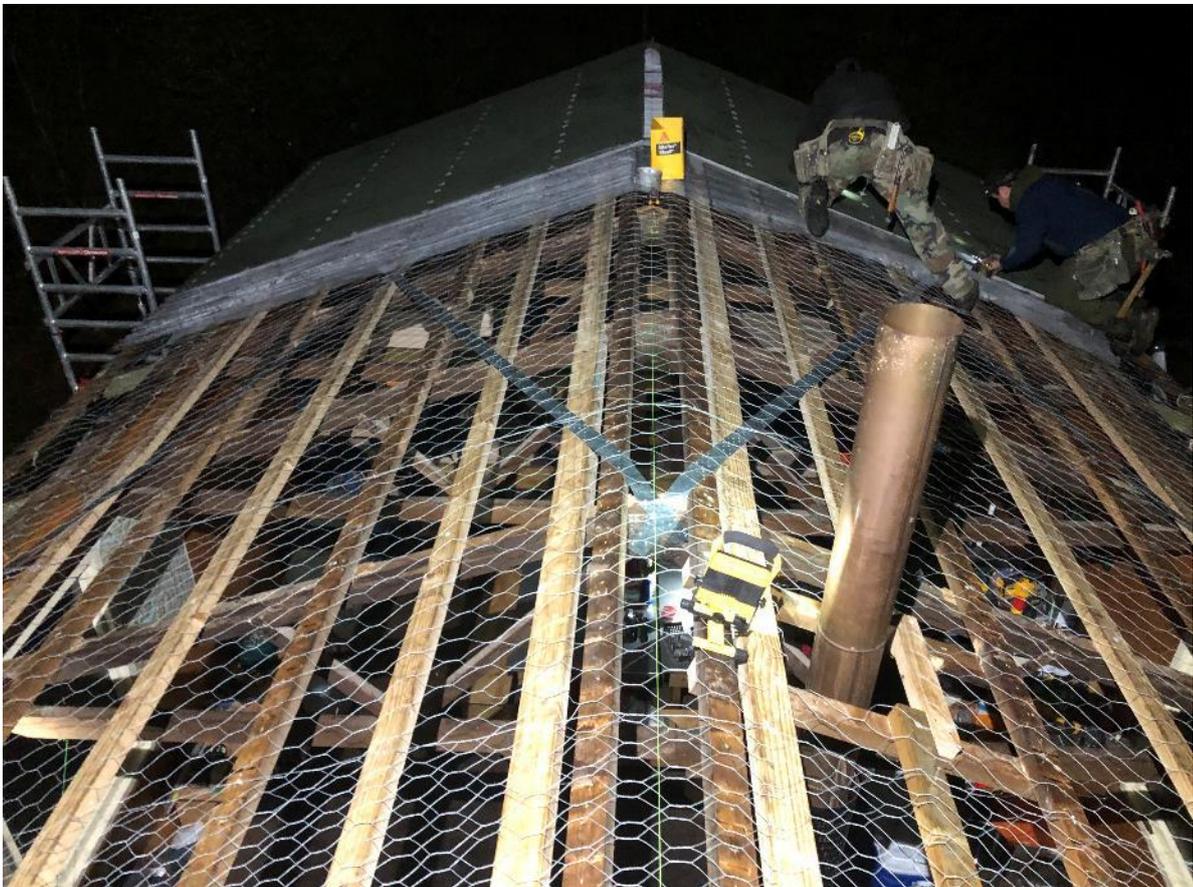
**Night works reroofing**

At 11.45pm the last bit of iron went on with some temporary stropping of the chimney and final sheets to tide us through the night and finally the fire was alight to dry out the trampers soaking clothes for them.

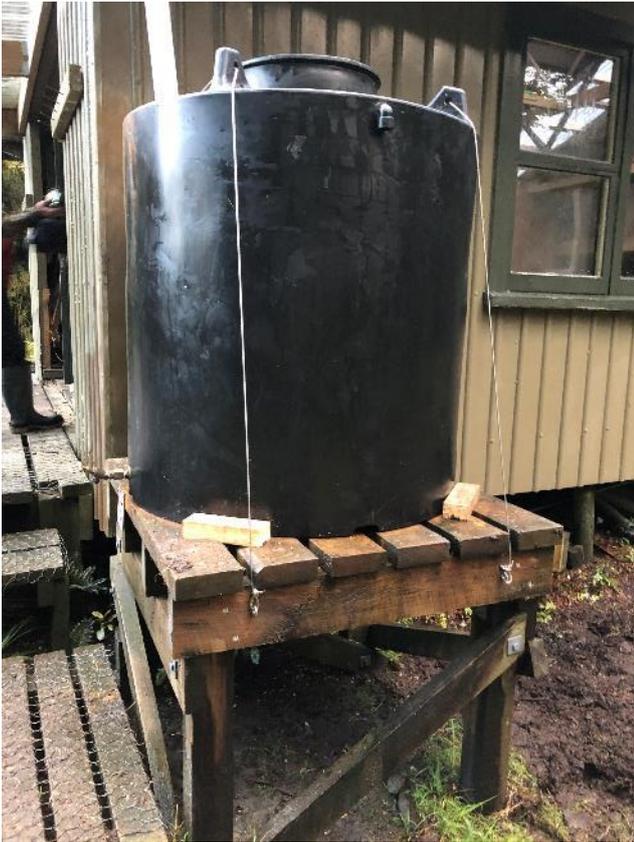
Cleaned and new seismic restraints on tank

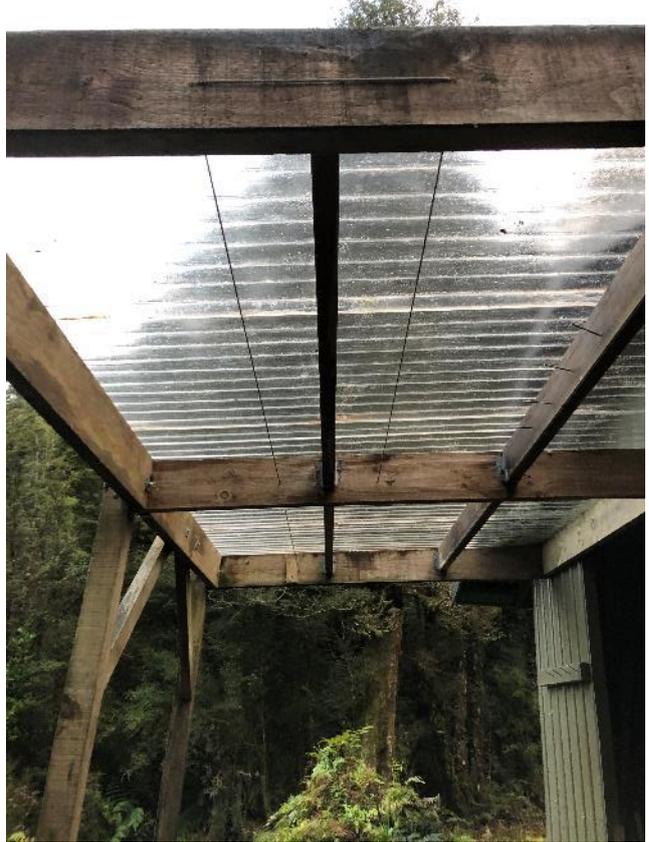
Cleaned deck cover and new clothes line

The porch clearlight was cleaned of moss and lichen and the hut cleaned inside thoroughly.

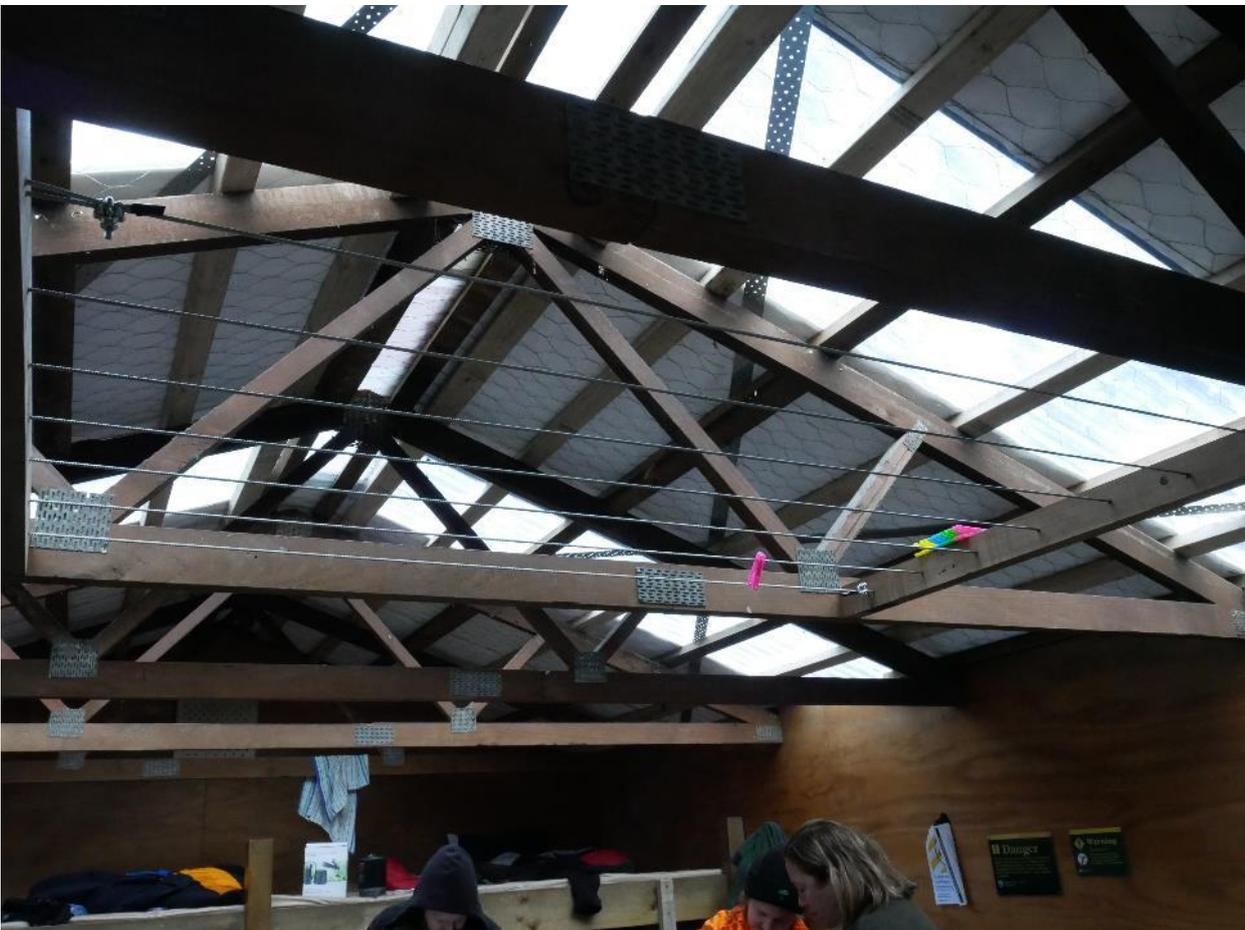
New Fireplace clothes line

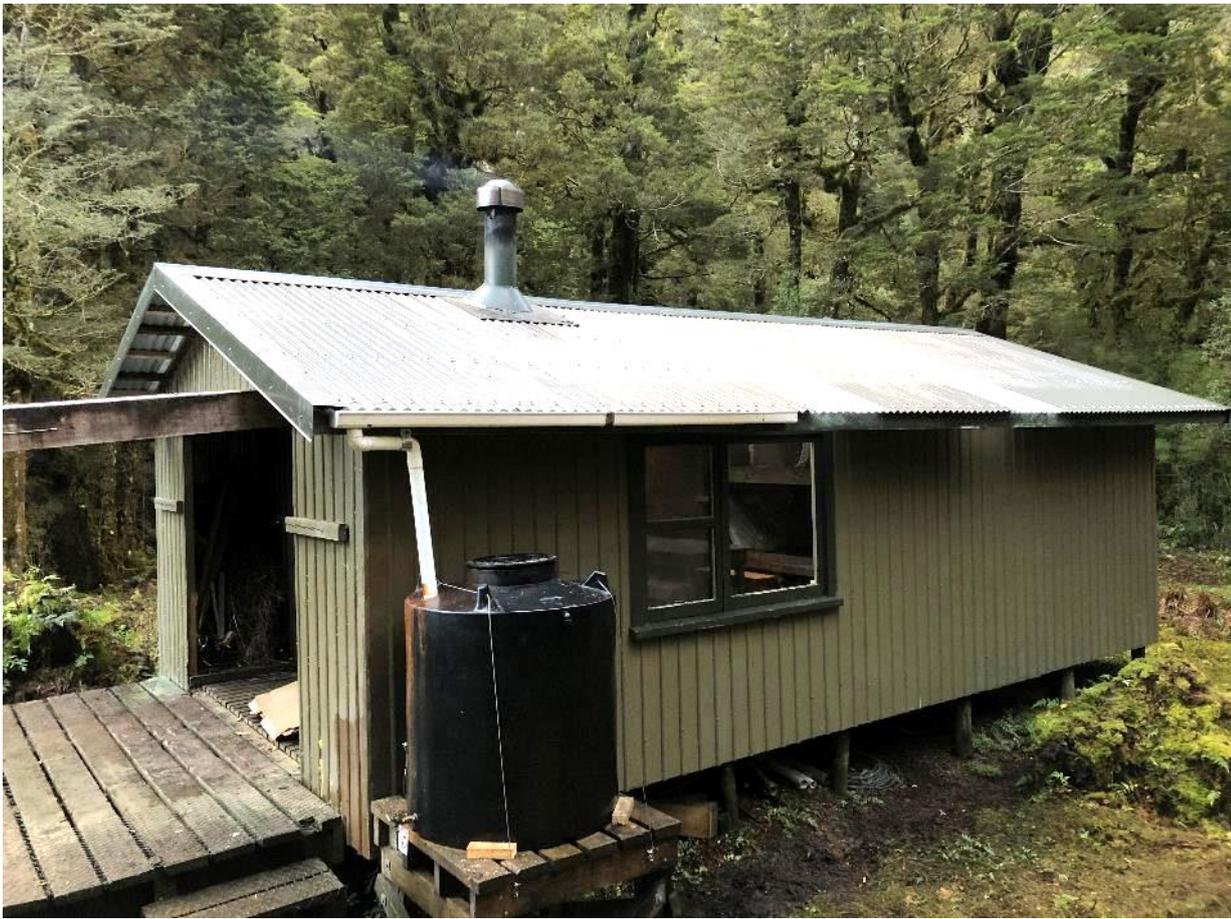
**Completed reroof**
