**New Zealand
Outdoor Recreation
CONSORTIUM**

Top Crooked Hut

Worked completed

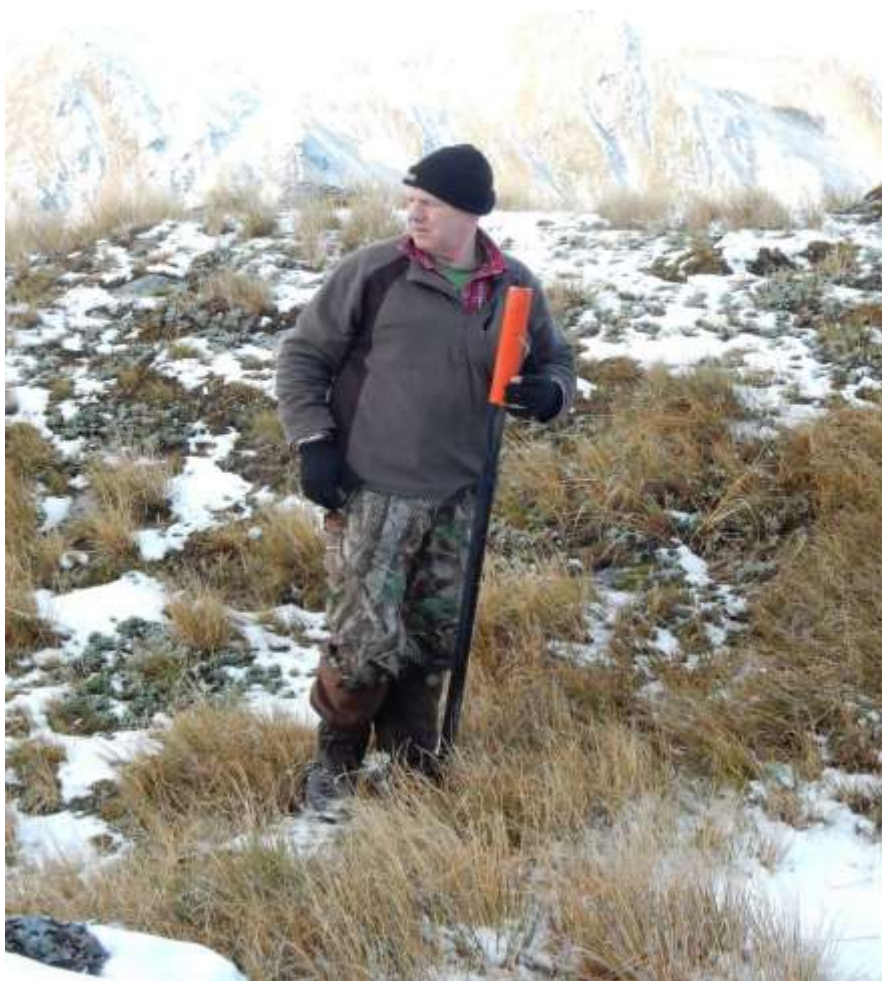
Above: Craig Benbow positioning a new waratah

Saturday 23 May dawned fine & crisp with a dusting of snow overnight. We climbed the steep & freshly cut track to the bush-line & onwards & upwards through sub-alpine scrub to the 1260m contour & a flat spot where the orange sleeved waratahs & post driver had been flown to the day before. We gathered them up & continued climbing the spur & begun driving in the waratahs at regular intervals as previously there was a distinct absence of them. We followed an obvious terrace/ bench at about the 1350m contour towards the east which heads towards a low point on the main Morgan Tops. The last waratah we put in place was at 1420m. Map grid reference 1492850 5272930 or NZ Topo50 Map BU21 928 729. We returned the same way & 'drove home' a few more waratahs between the point they were dropped at & the bush-line. Refer to www.remotehuts.co.nz for a route description from Top Crooked Hut up on to the Morgan Tops.

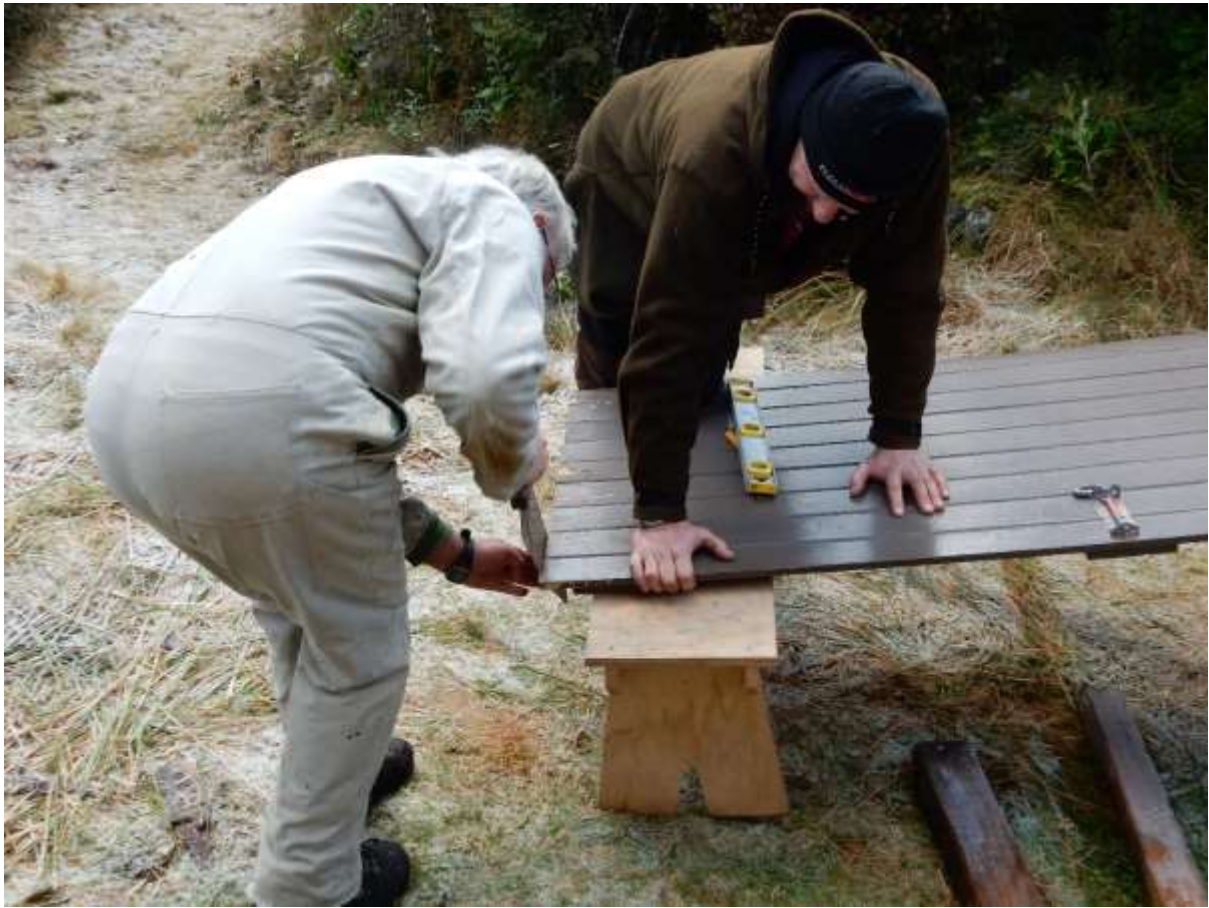
Above: Martin Clapham (L) & Craig Benbow (R) trimming the base of the door

Sunday 24 May again dawned fine, so we set about doing some work on & around the hut. The hut door was removed & the bottom trimmed off as it was scragging the floor where the base of the door had swollen from water ingress. To complement the trimmed door base a metal door sill was

cut to measure & installed. A liberal amount of Metalex was applied to the wood surface prior to attaching the flashing.

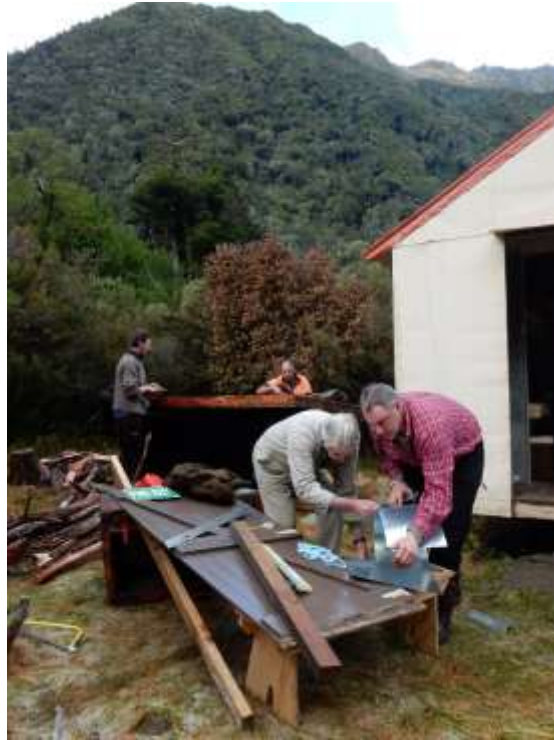
Above: William Benbow (left rear), Kevin Cohen (right rear), Martin Clapham (left front) & Craig Benbow (right front) hard at work

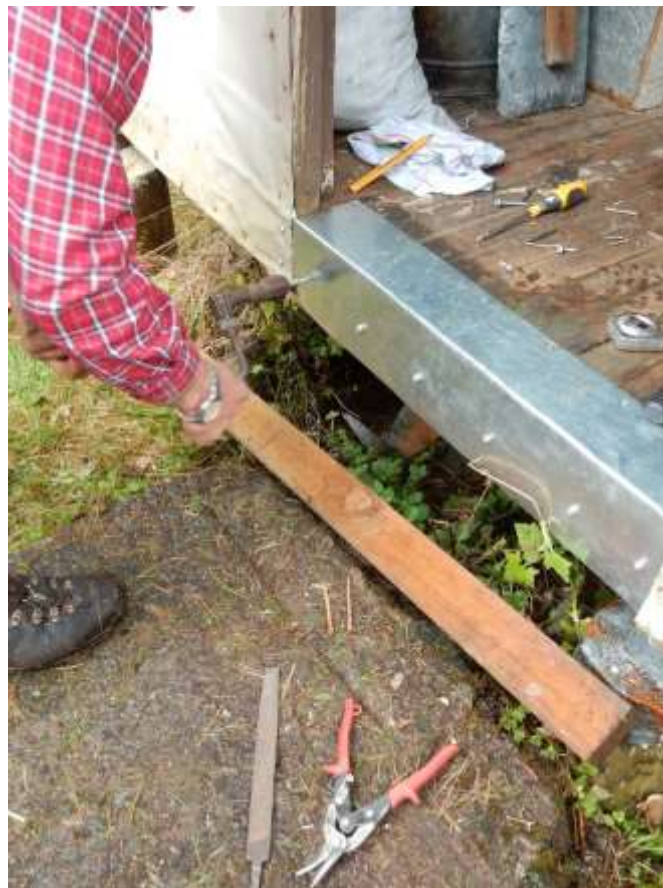
Above: Securing the new door sill flashing

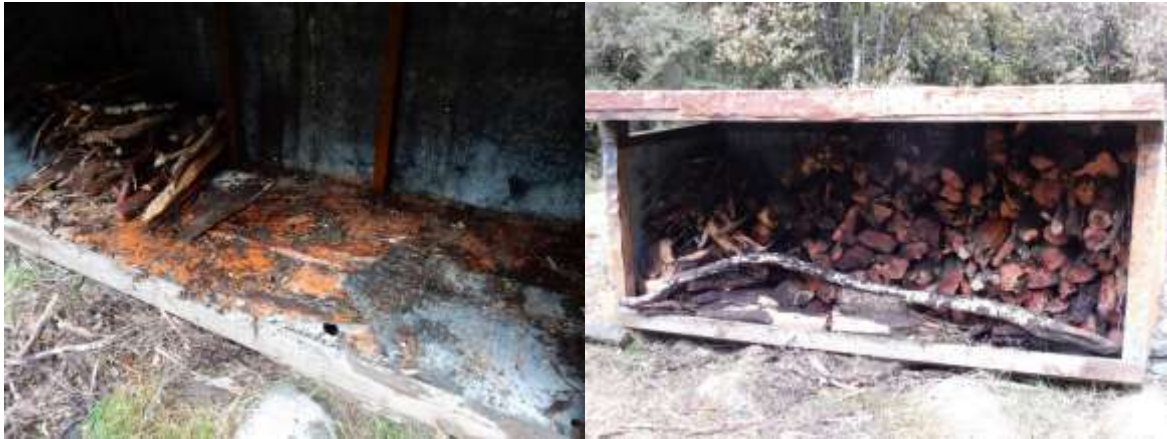
Above: Wood shed before & after

The dwarf-height wood shed was cleaned out & restocked with firewood that DOC had cut into rings. Based on the 10 or so parties to visit Top Crooked Hut yearly there is quite a few years' worth of wood cut & split, awaiting to heat the hut.

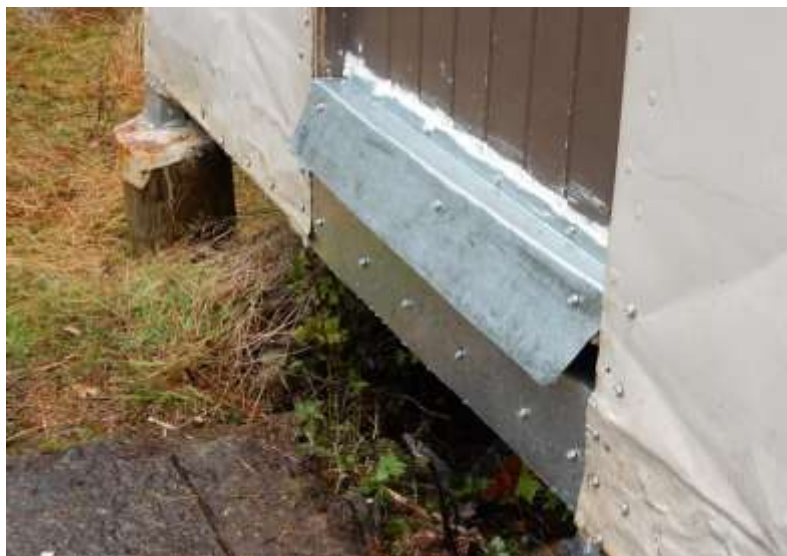
Above: New door sill & door angle flashing

An angle door flashing was moulded to the base of the door to direct water away. Where the flashing meets the door a liberal amount of sealant was applied. To attach the angle flashing an additional piece of treated timber was screwed into place that allowed us to realign & permanently sandwich the loose tongue & groove door boards. Small flashings were made to cover the ends of the floor bearers as seen on the far left pile in the photo below. The outside piles we had planned on replacing were not replaced because they are in good condition.

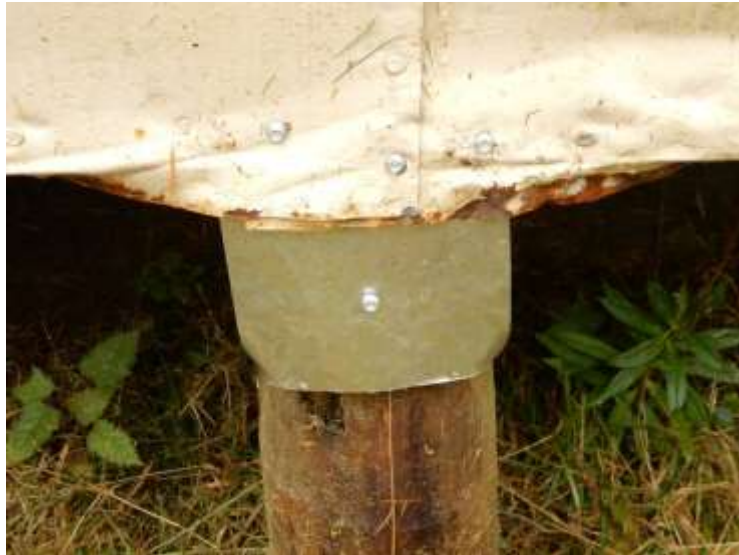
Above: Flashings on pile bearers

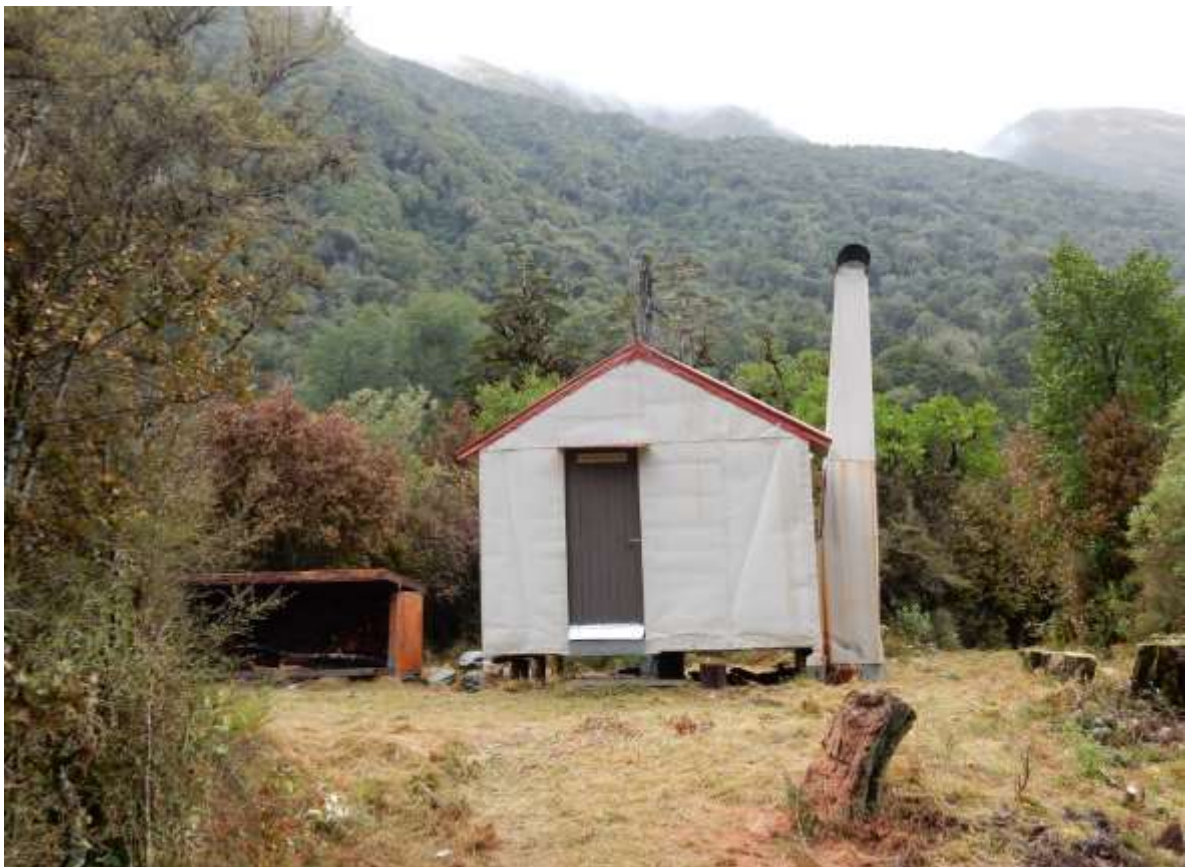
A significant amount of shrubbery & vegetation was cleared away from the front of the hut to let more light & air in to the hut site. Vegetation was removed from around the piles & base of the hut. The hut now has a view of the river on the terrace below.

Loose & rusted lead-head nails were replaced on the hut roof with hex-head rubber washer screws & likewise, to flat-head nails on the exterior walls of the hut.
