Report on Explorer Hut

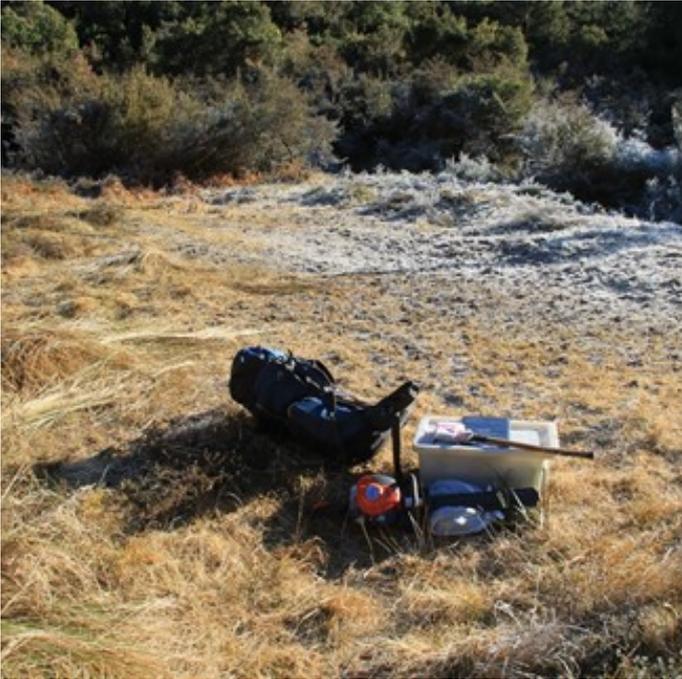
Cleared Chopper Pad

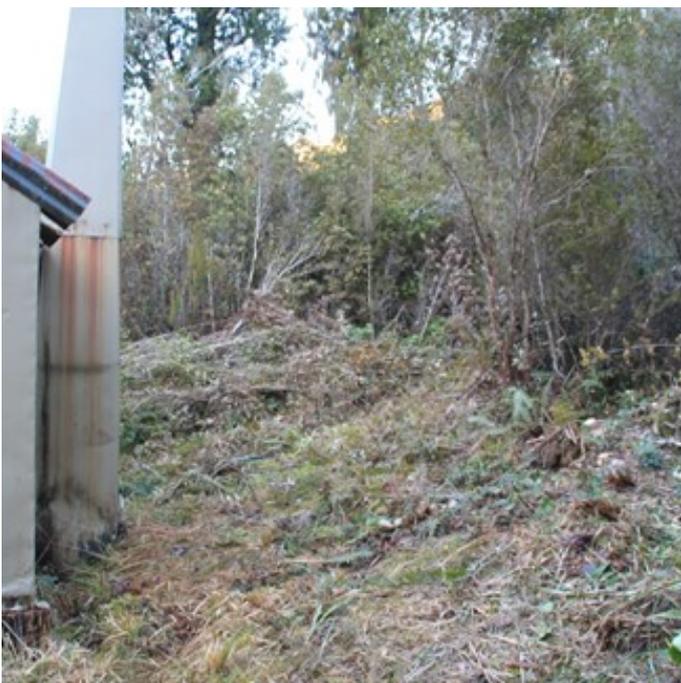
Scrub Cleared From Round Hut

When we got back to the hut we cleared back the scrub from round the hut by about 2-3 mt. and then cleared a patch of scrub at the back of the hut for the future woodshed.

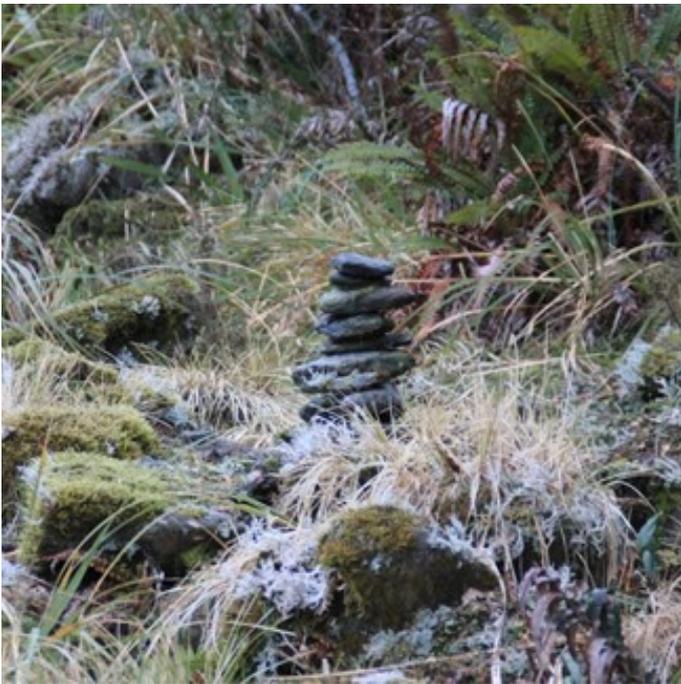
Cairn at Vanina Stream

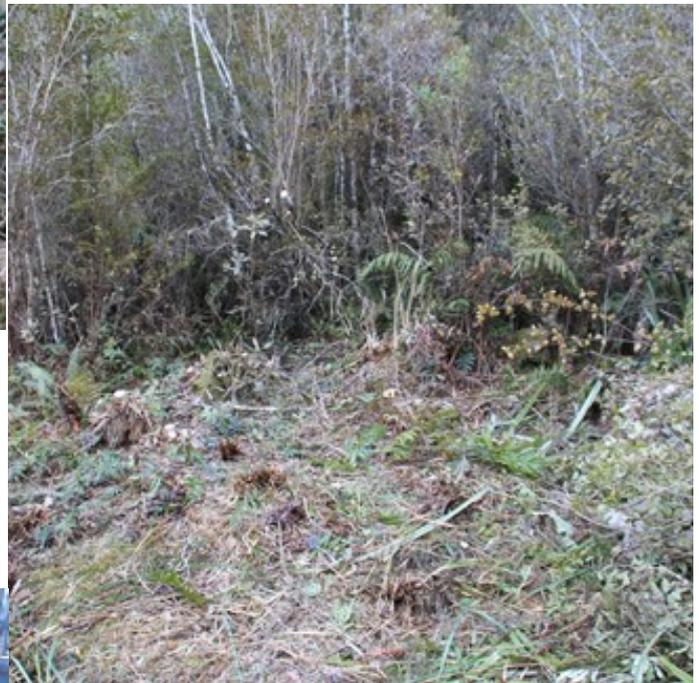
clearing For Woodshed

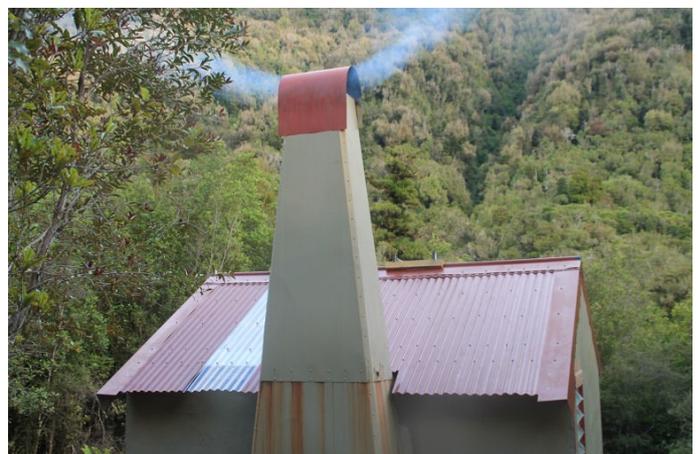
Roof and sky light on

We replaced the roofing iron, sky light and added a new ridge cap and side flashings. Then painted the roof and walls with rescue orange. An undercoat was put on the walls after we washed all the mould and lichen off before the top coat of orange also.

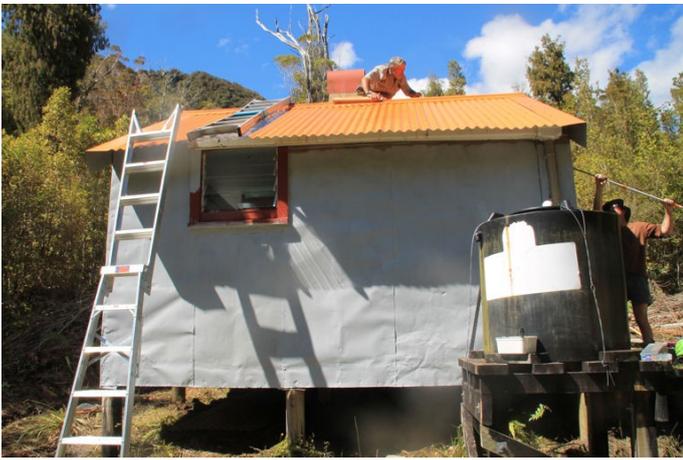
Roof and walls painted

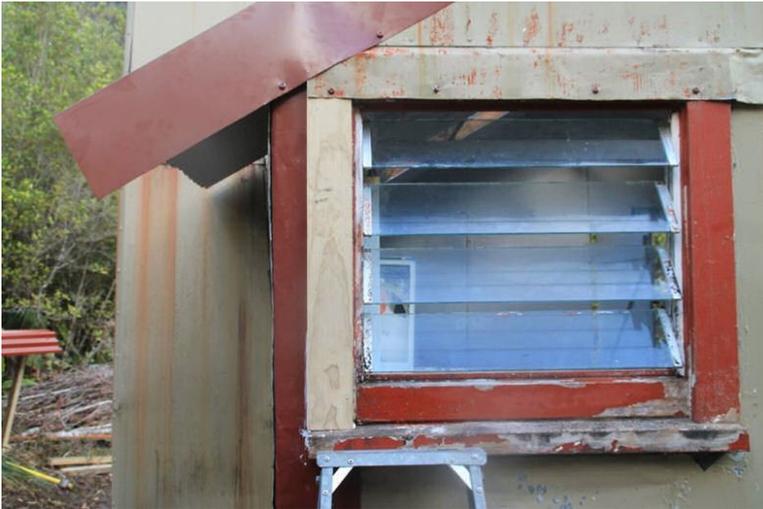
Window put back in wall

The studs and dwangs for the hut corner and window were replaced and the window space lined on the bottom with tar sealer. The window was then replaced and a new piece of sash attached.

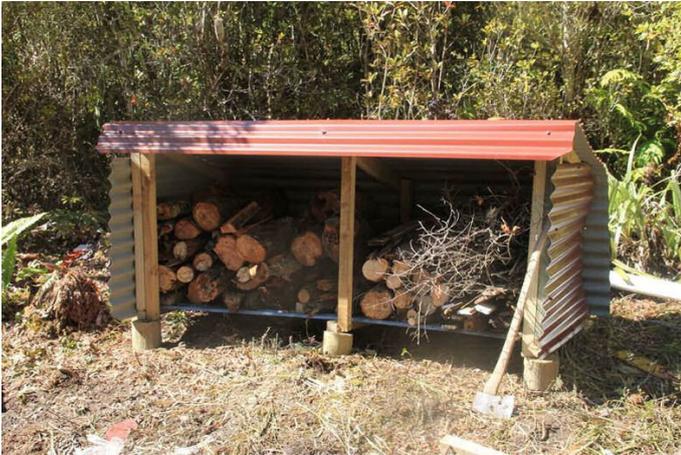
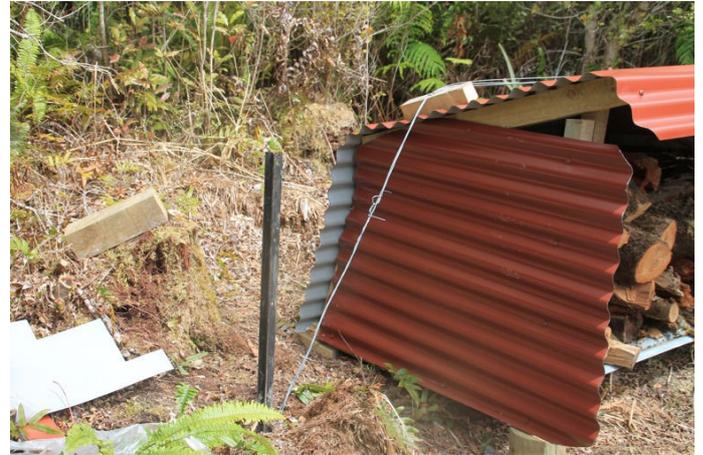
Wood shed full of wood and detail of tie down

We then built a wood shed with timber off cuts and tin not used on the hut and tied it down with 4 strands of 12 gauge wire

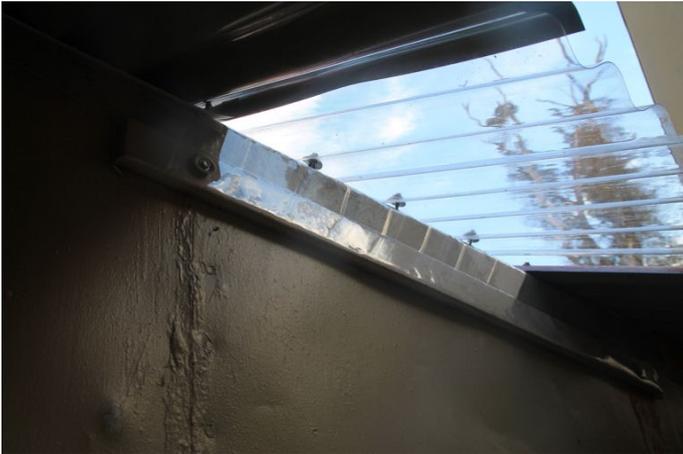
Clear PVC rolled over baton under the clear light

Under the new sky lights we secured a sheet of clear PVC to direct any condensation to the outside of the roof. This was rolled round a baton and secured down the wall.

The PVC required to be well attached to the top of the ridge line and secured down each side because over time it will shrink from the sides if they are not secure

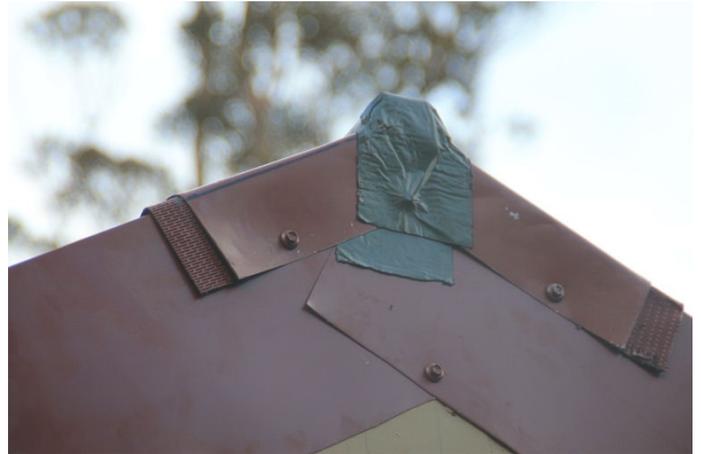
End of ridge cap fixed and sealed
