TUNNEL CREEK HUT PARINGA VALLEY SOUTH WESTLAND APRIL 2015

Geoff Spearpoint

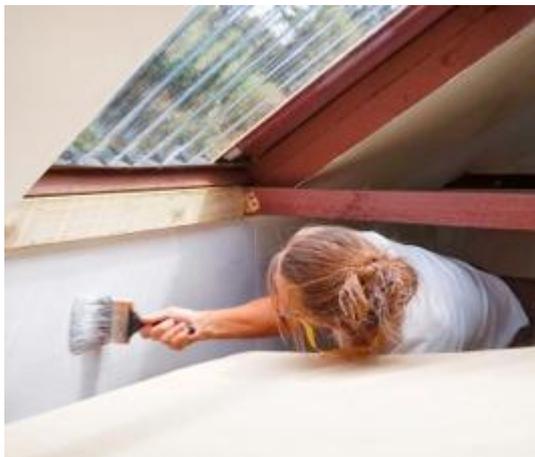
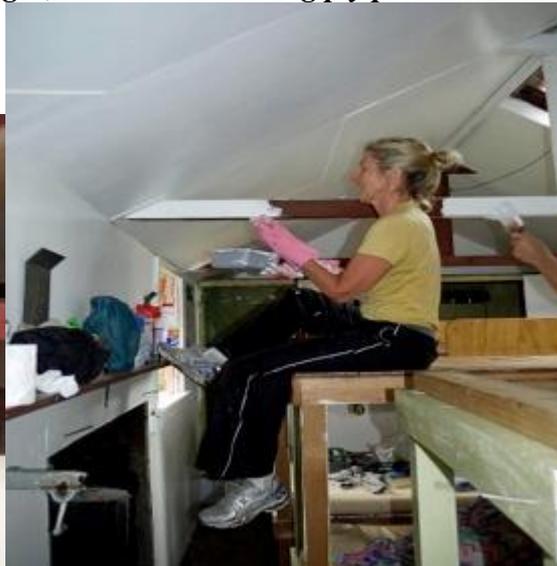
Left, Tracy Lee painting (Photo-Hugh van Noorden) and Right, Liz painting.

All the warped and delaminating sheets of ply on the walls and ceiling were replaced. The bunks were pulled out from the walls and put in the middle of the room then all the interior walls and ceiling were scrubbed down with what detergents we had and cleaned off before painting. They were given mostly three coats of white semigloss paint.

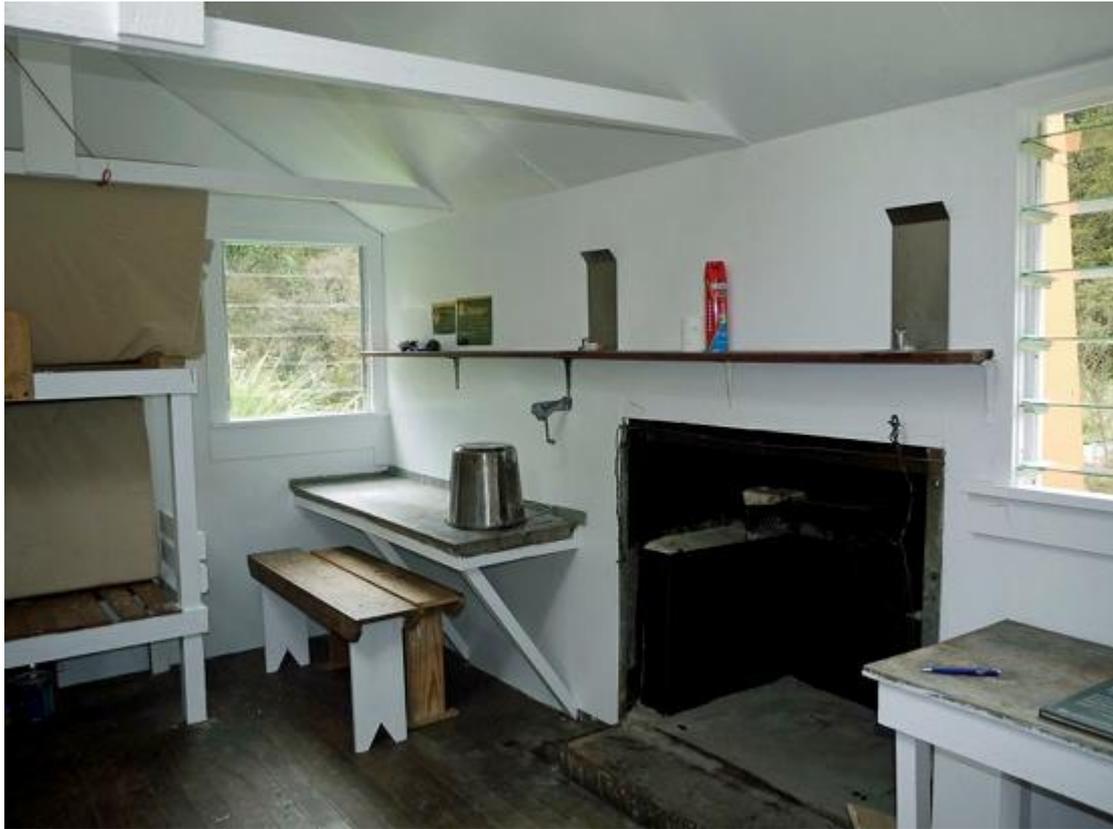
Above, The interior of the hut finished, March 2015, Below, the inner porch restored.
