Stoney Creek Hut, Shotover Area, Queenstown

Refurb Project March 10-15 2019

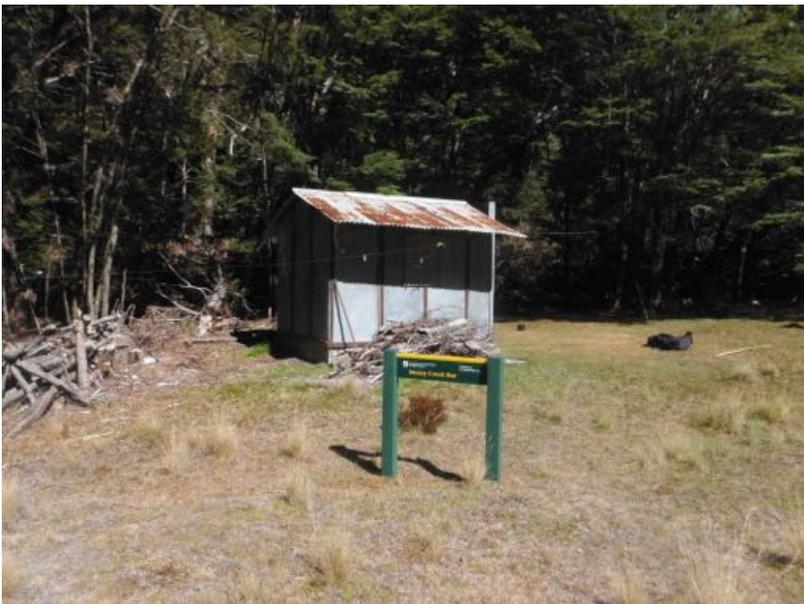
Stoney Creek Hut, December 2018

This Hut is unique insofar it has dexion framing. From weights painted on various items and location abbreviations marked on different studs and components, it can be safely assumed the hut was pre fabricated off site and flown in in pieces by helicopter. The valley is too steep and narrow for it to have been dropped from a fixed wing plane.

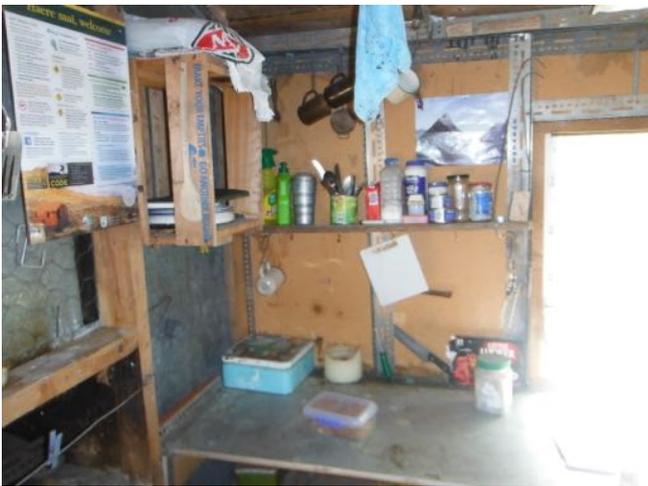
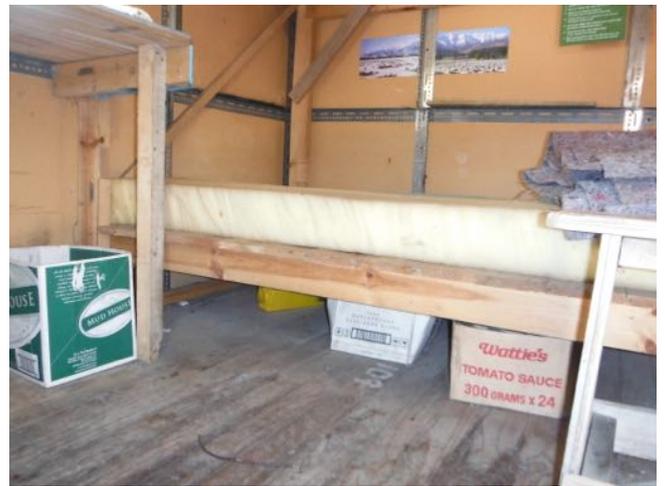
When I visited this hut in April 2017, some trees had been fallen on the hut and were still resting against the roof. There had been a heavy snowfall in November 2016 which I believe to be the cause of the trees falling over. The damage was mostly to the large overhangs (eaves) of the roof .

Interior, December 2018

Water was coming in under the door and also down the chimney causing the floor to rot. It was dark inside the hut even on the brightest days due to the brown pinex lining, one window and massively long un-supported eaves which had folded down from both snow loading and some tree falls.

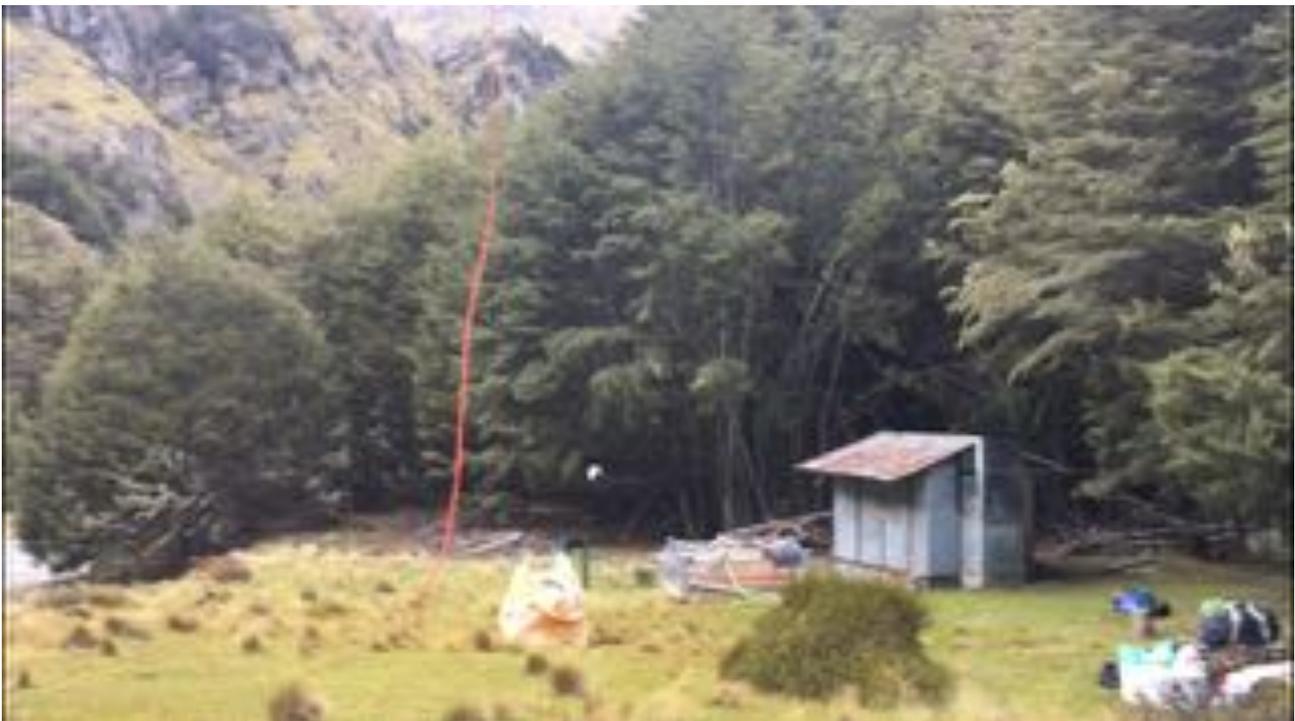
Longline load from Maori Point just arrived beside hut

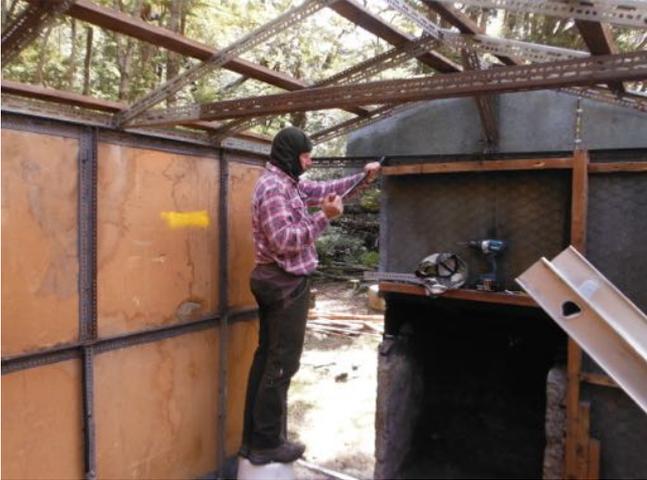
Ed stripping walls

Day 1 Strip out interior of hut, remove roofing iron. Replace & repair pearlins and fit pearlins along eaves. Fit ply and building paper to roof. Remove window and door. Start stripping wall cladding.

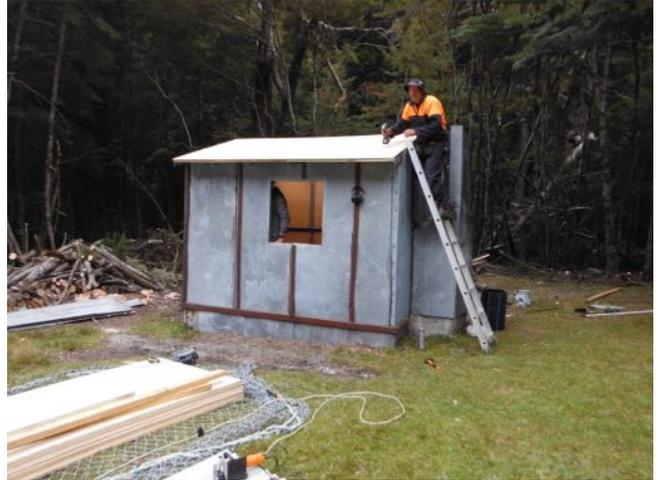
Mike fixing ply to roof

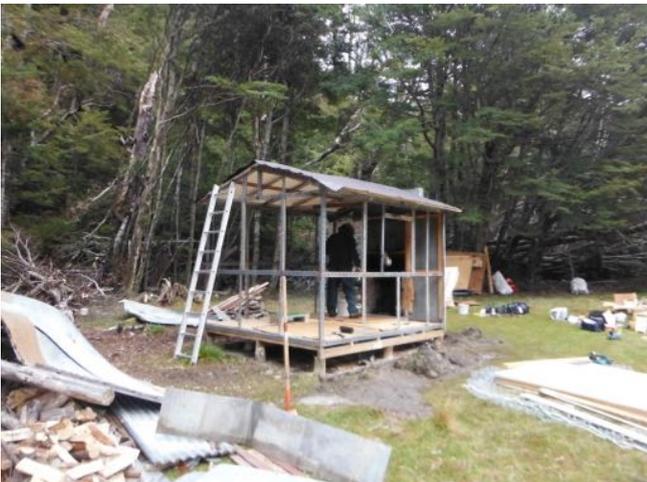
Ceiling on to provide bracing

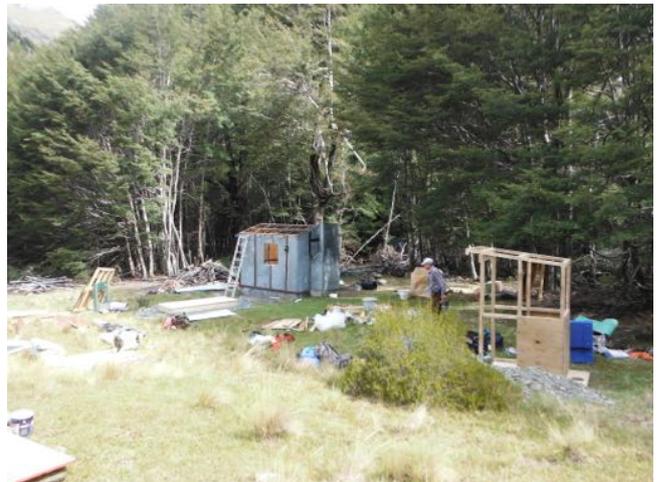
Toilet construction

Day 2. Assemble toilet, dig hole and clad toilet with new colour steel. fit new colour steel to roof. Remove hut wall cladding and pinex. Fit ply to rear wall, building paper and refit cladding. Paint hut door.

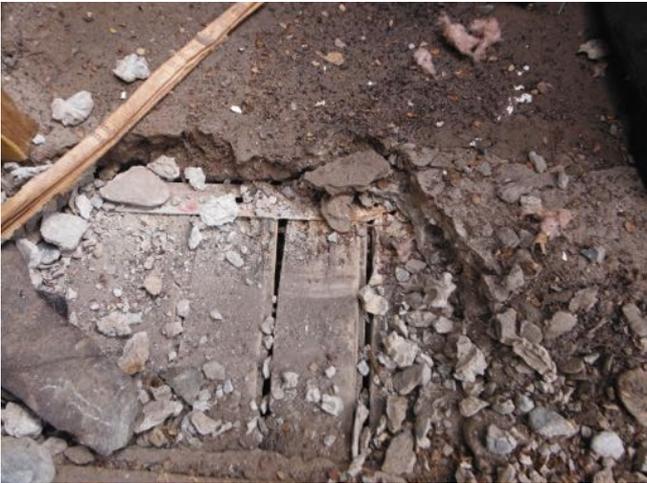
Floorboards under old hearth

Day 3. Deconstruct fireplace and wall, break away old hearth to reveal extent of floor rot. Replace 2 floor joists and 18 pieces of T&G floor. Repair broken fireplace and work on new hearth and fireplace improvements. Complete toilet and assemble woodshed. Clad woodshed roof with new colour steel and fit old roofing iron to walls and paint Karaka green.

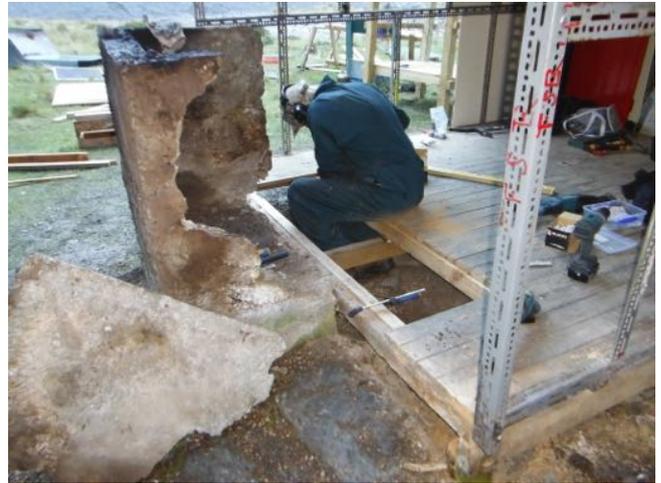
New joists and floorboards. Note broken Fireplace

The Fireplace falling apart could have been a real issue and it was looking like the only option was to blank it off and return another day to rebuild it. Luckily, we had a bag of cement for the new hearth. Alan McLeod took repaired and rebuilt the firebox to even better than before. To me, that is the real standout story for this project.

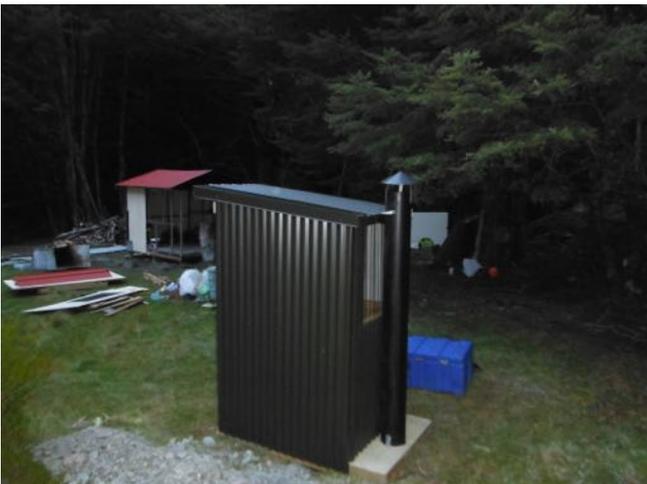
Toilet completed, hut roof on

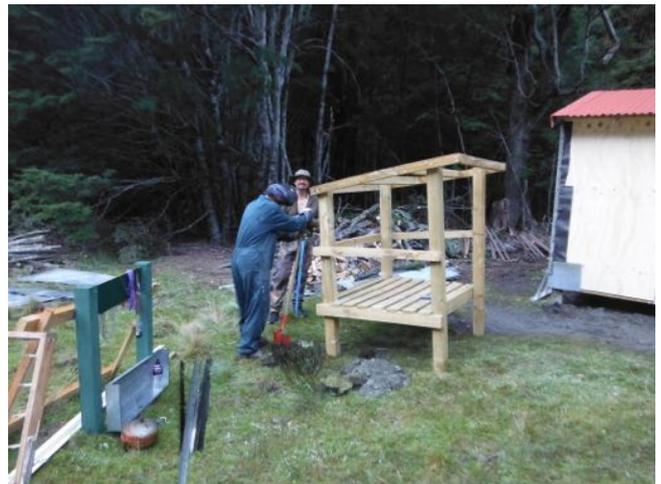
Alan & Neale assembling the wood shed

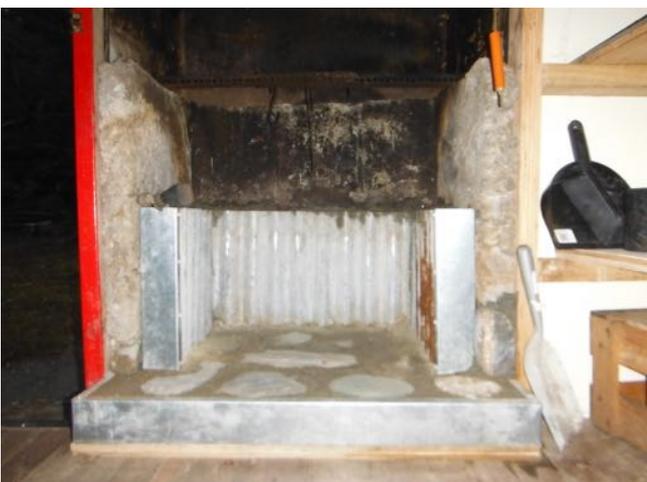
Alan McLeods masterpiece.

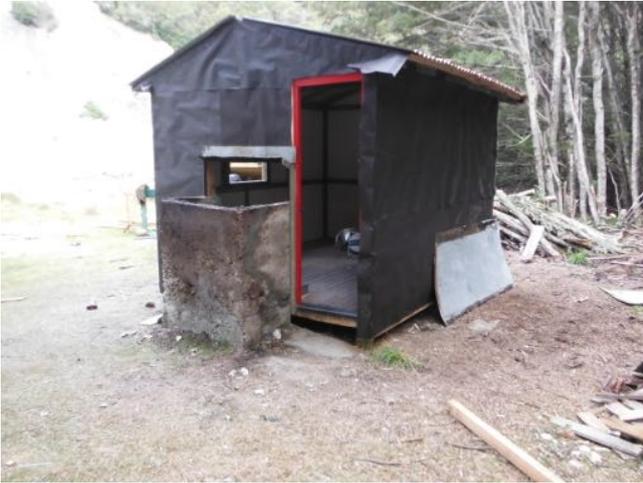
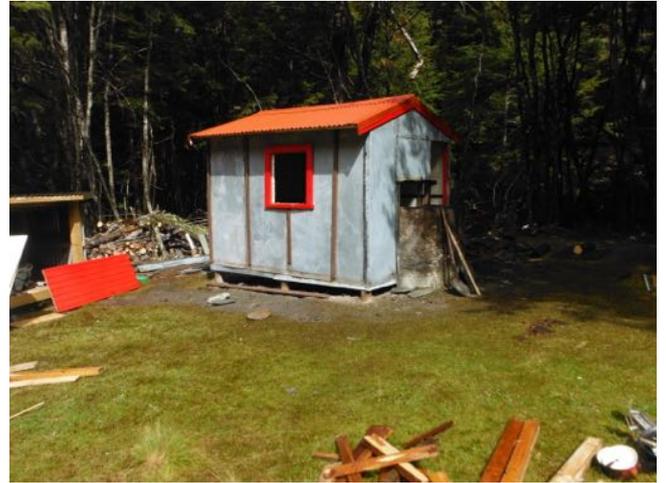
Roof and cladding finished

Day 4 Finish framing fireplace wall, fit new door frame and finish lining interior and fit exterior cladding. Refit window with new facings and paint. Fit bug screen to window. Fit barge boards and flashings and ridge caps. Rebuild bunks.

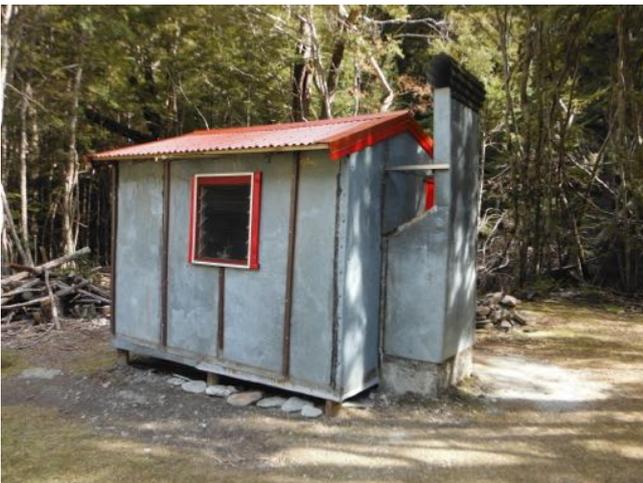
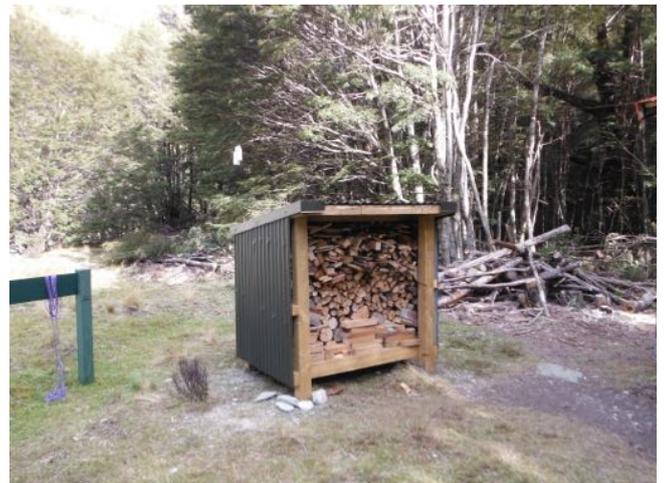
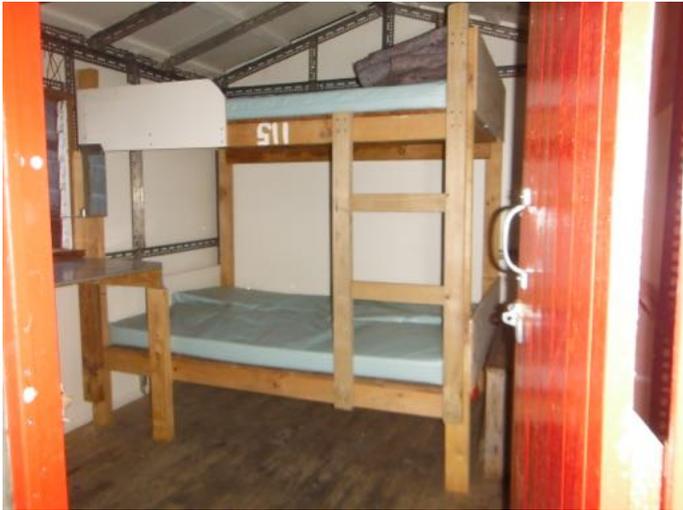
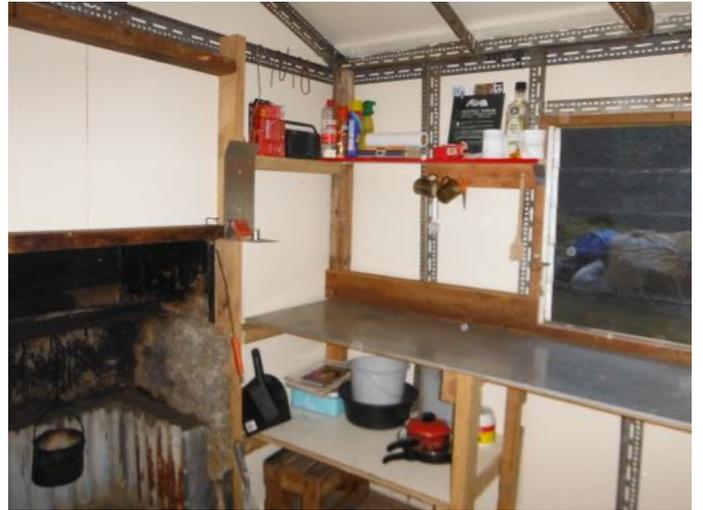
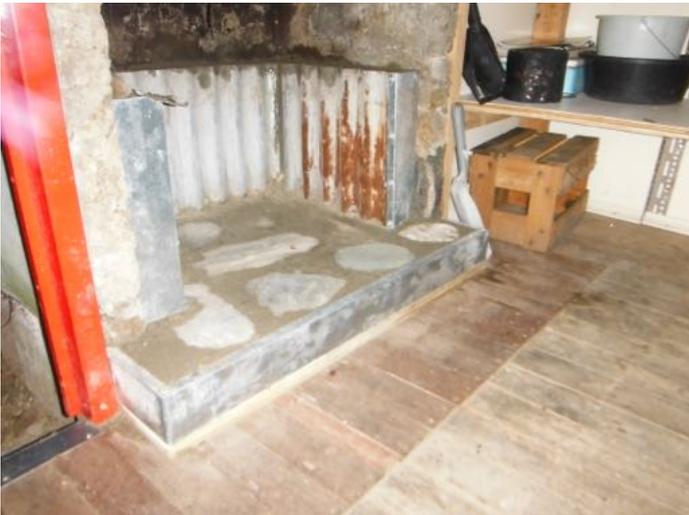
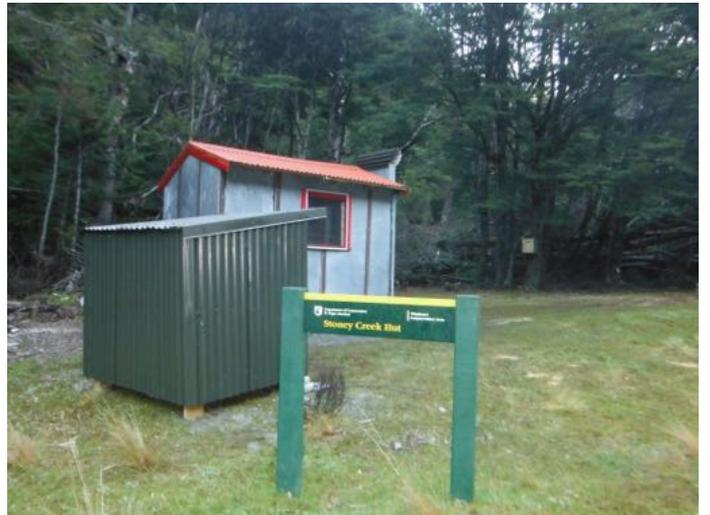
Day 5 Hang door in frame. Finish bunks with roll out protection and a ladder. Rebuild and install bench. Fit cladding to fireplace and install chimney. Strengthen chimney and brace back to hut. Fit weather cap to chimney. fill woodshed with wood. Clean up site, load net and prepare for flight out.
